A STUDY OF DUST CONDITIONS

BRIDGEPORT AND STRATFORD, CONN. PLANTS

RAYBESTOS DIVISION OF THE RAYBESTOS-MANHATTAN, INC.

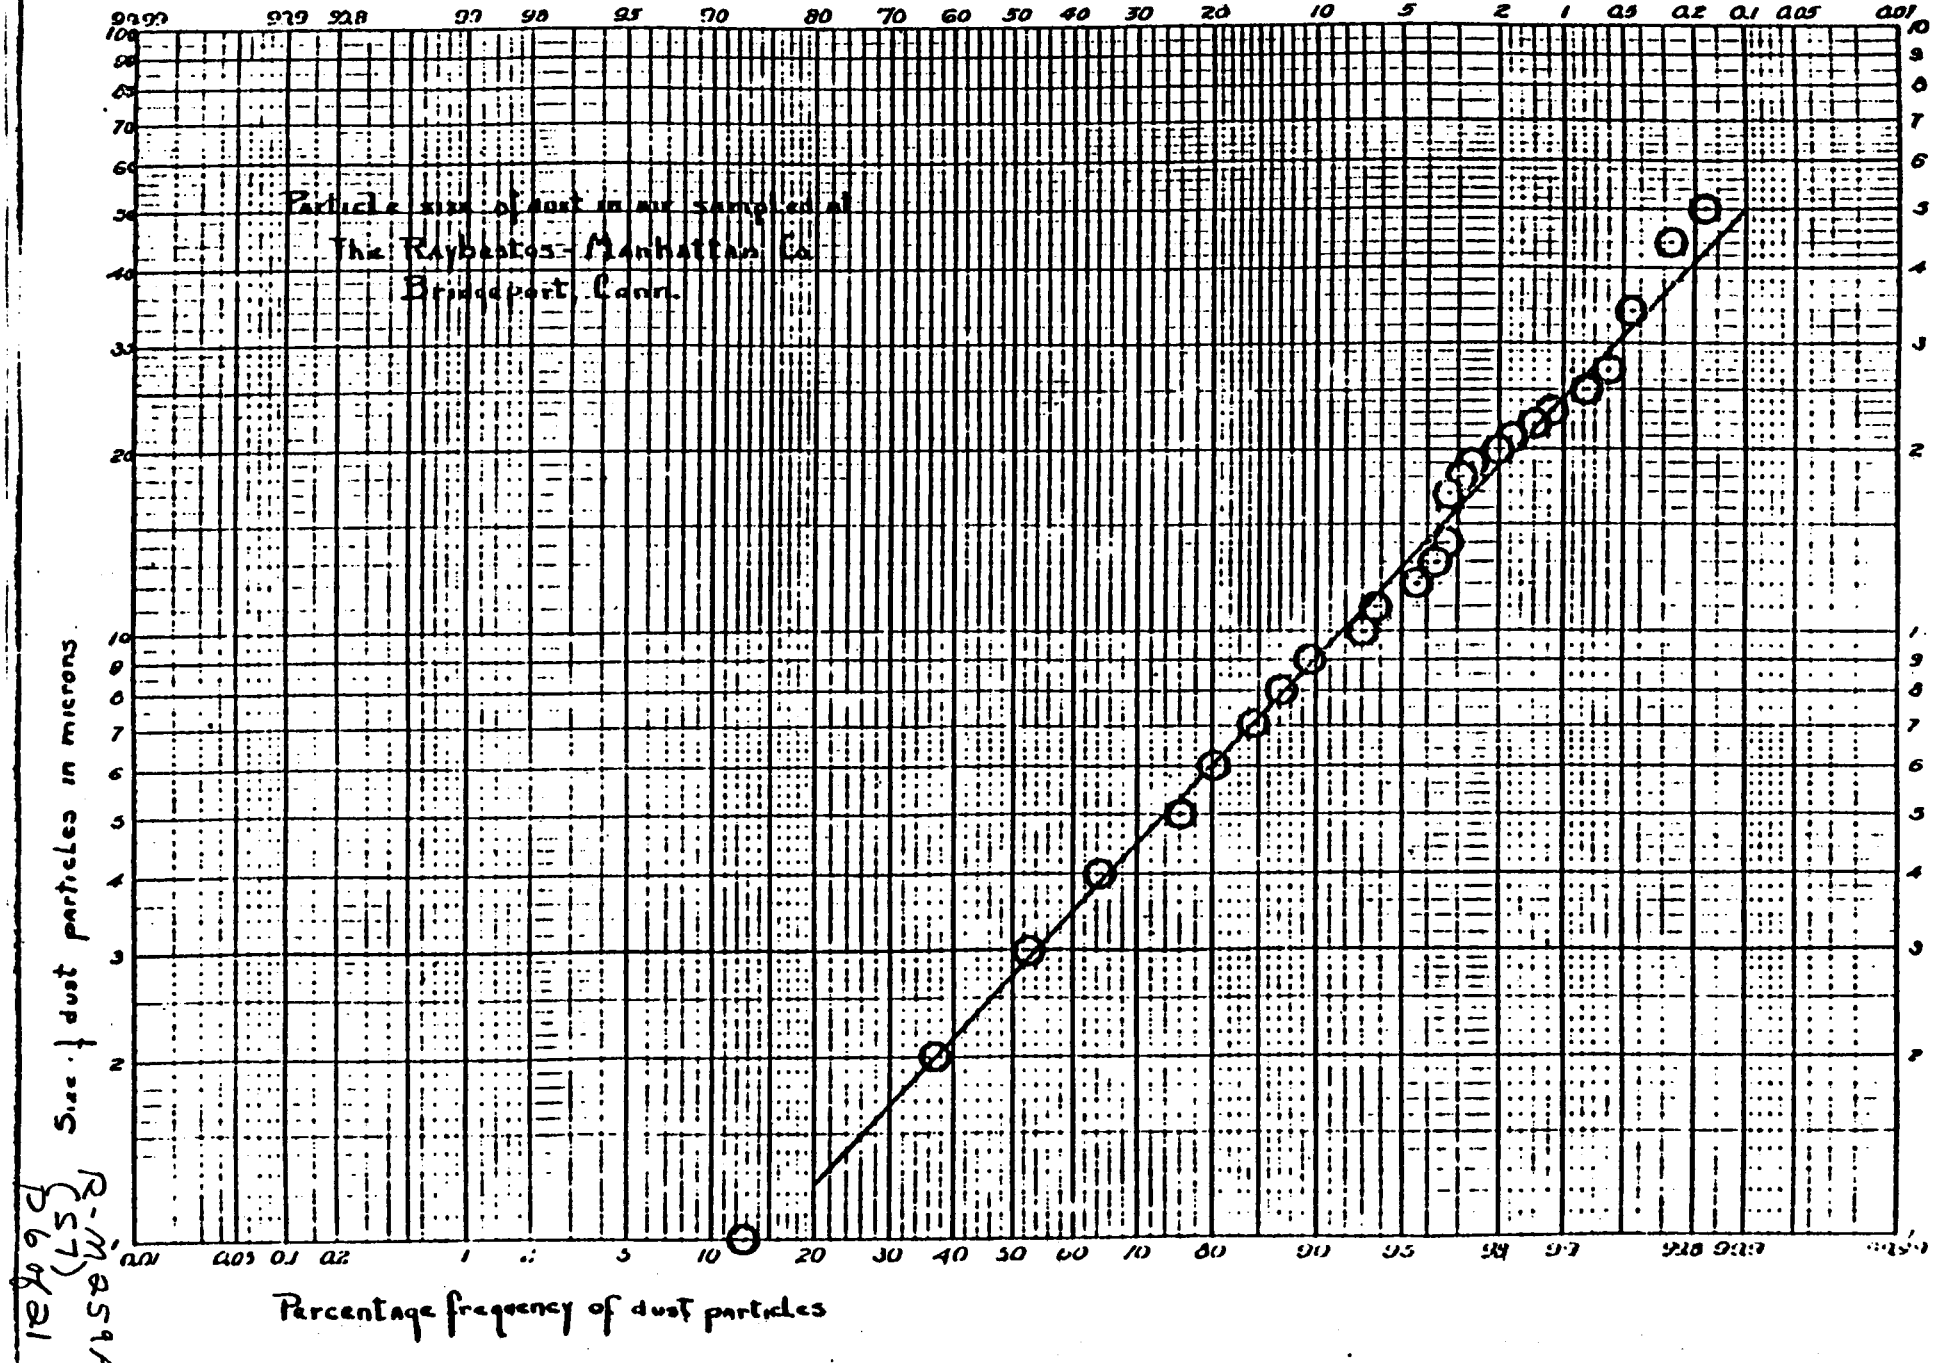
Particle size measurements of the dust were made and the results are recorded in the attached graph from which the percentage of the various sizes can be determined. It will be noted from the curve that 95% of the particles are less than 10 microns in their greatest diameter.
