Subject Insulation Block Dust Survey
Construction Insulation Shop
Plant 511

INDUSTRIAL HYGIENE SURVEY

Construction Insulation Shop - Building 511-2018

Report 63-IH-3-G-1

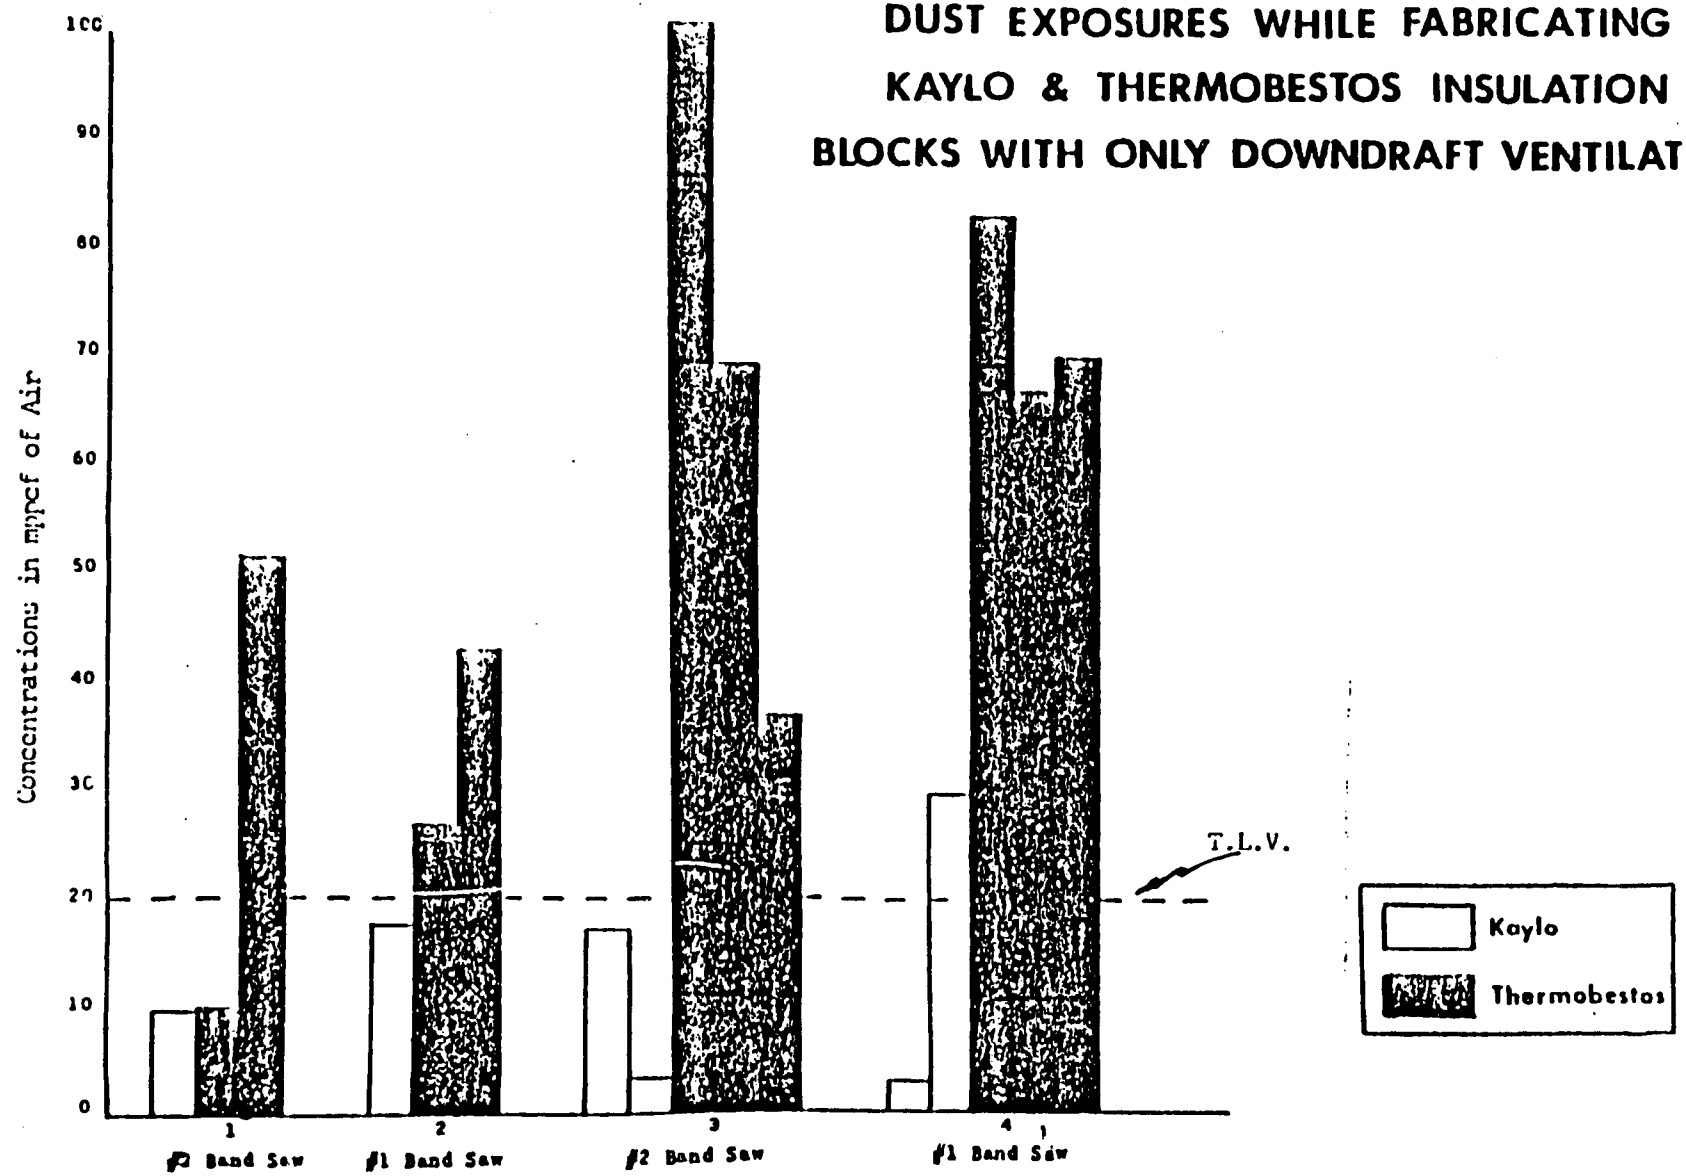
GRAPH NO. 1

Relative to dust exposures from Graph #1 & Tables on Pages 8 & 9:

1. "Thermobestos" insulation blocks should not be fabricated when using only the original downdraft exhaust ventilation.

2. "Kaylo" insulation blocks could be fabricated safely when using only the original downdraft exhaust ventilation if existing leaks, observed on the #1 band saw, are corrected.

3. "Kaylo" insulation blocks definitely may be safely fabricated when using the entire exhaust ventilation facilities now available, i.e., hoods above the blocks as well as below.

DUST EXPOSURES WHILE FABRICATING KAYLO & THERMOBESTOS INSULATION BLOCKS WITH ONLY DOWNDRAFT VENTILATIOI

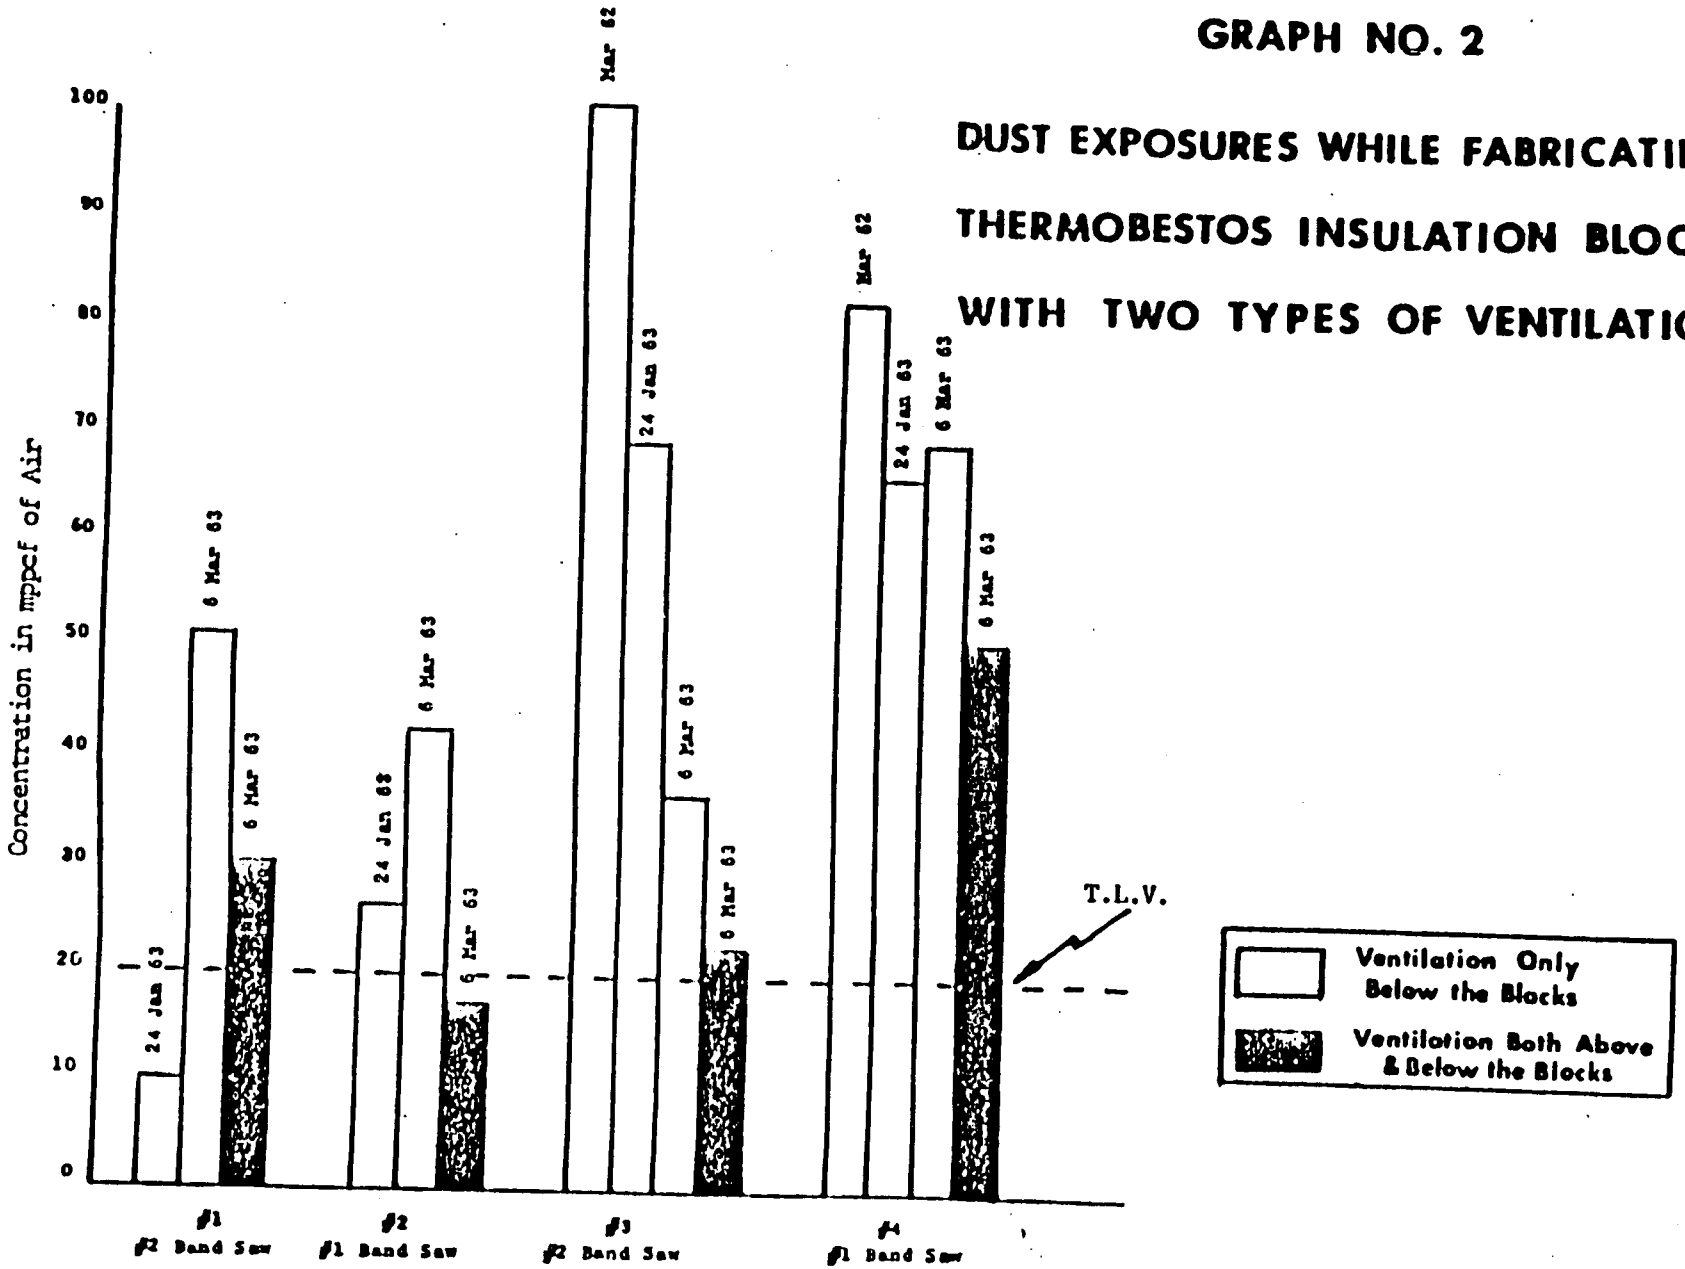
GRAPH NO. 2

From Graph #2 & Tables on Pages 8 & 9:

1. Methods of handling "Thermobestos" blocks (preparatory to sawing) and scraps (after sawing) contribute greatly to specific individual exposures as demonstrated by the following facts:

a. The fabrication process, which always begins at the #2 band saw with the simple cutting of each 18" x 36" x 4" block into three smaller blocks about 18" x 12" x 4", is normally the least dusty of all the fabrication operations as revealed by the samples taken on 24 Jan 1963.

b. However, on 6 Mar 1963, this operation was revealed as being one of the dustiest, regardless of the ventilation being used.

c. There was only one major variable between the samples taken on the two dates, i.e., the method of handling the blocks preparatory to sawing. Consideration of the procedure used on these dates reveals: (1) that on 24 Jan 1963, the blocks were rolled up to the saw after having been removed from their shipping cartons and stacked on a "dolly" for easy individual removal and (2) on 6 Mar 1963, the blocks were not removed from their shipping cartons until needed by the worker. A large amount of dust is produced when blocks are removed individually from the cartons as a result of the natural abrasion produced when one block is pulled over the surface of the other. Consequently, the dust concentrations on this date at this location were greater than normal.

2. The supplementary overhead ventilation (added since the time of the preceding two reports) does successfully reduce the dust exposures. However, it does not reduce "Thermobestos" dust exposures to within safe acceptable limits when cutting radii.

DUST EXPOSURES WHILE FABRICATING THERMOBESTOS INSULATION BLOCKS WITH TWO TYPES OF VENTILATION

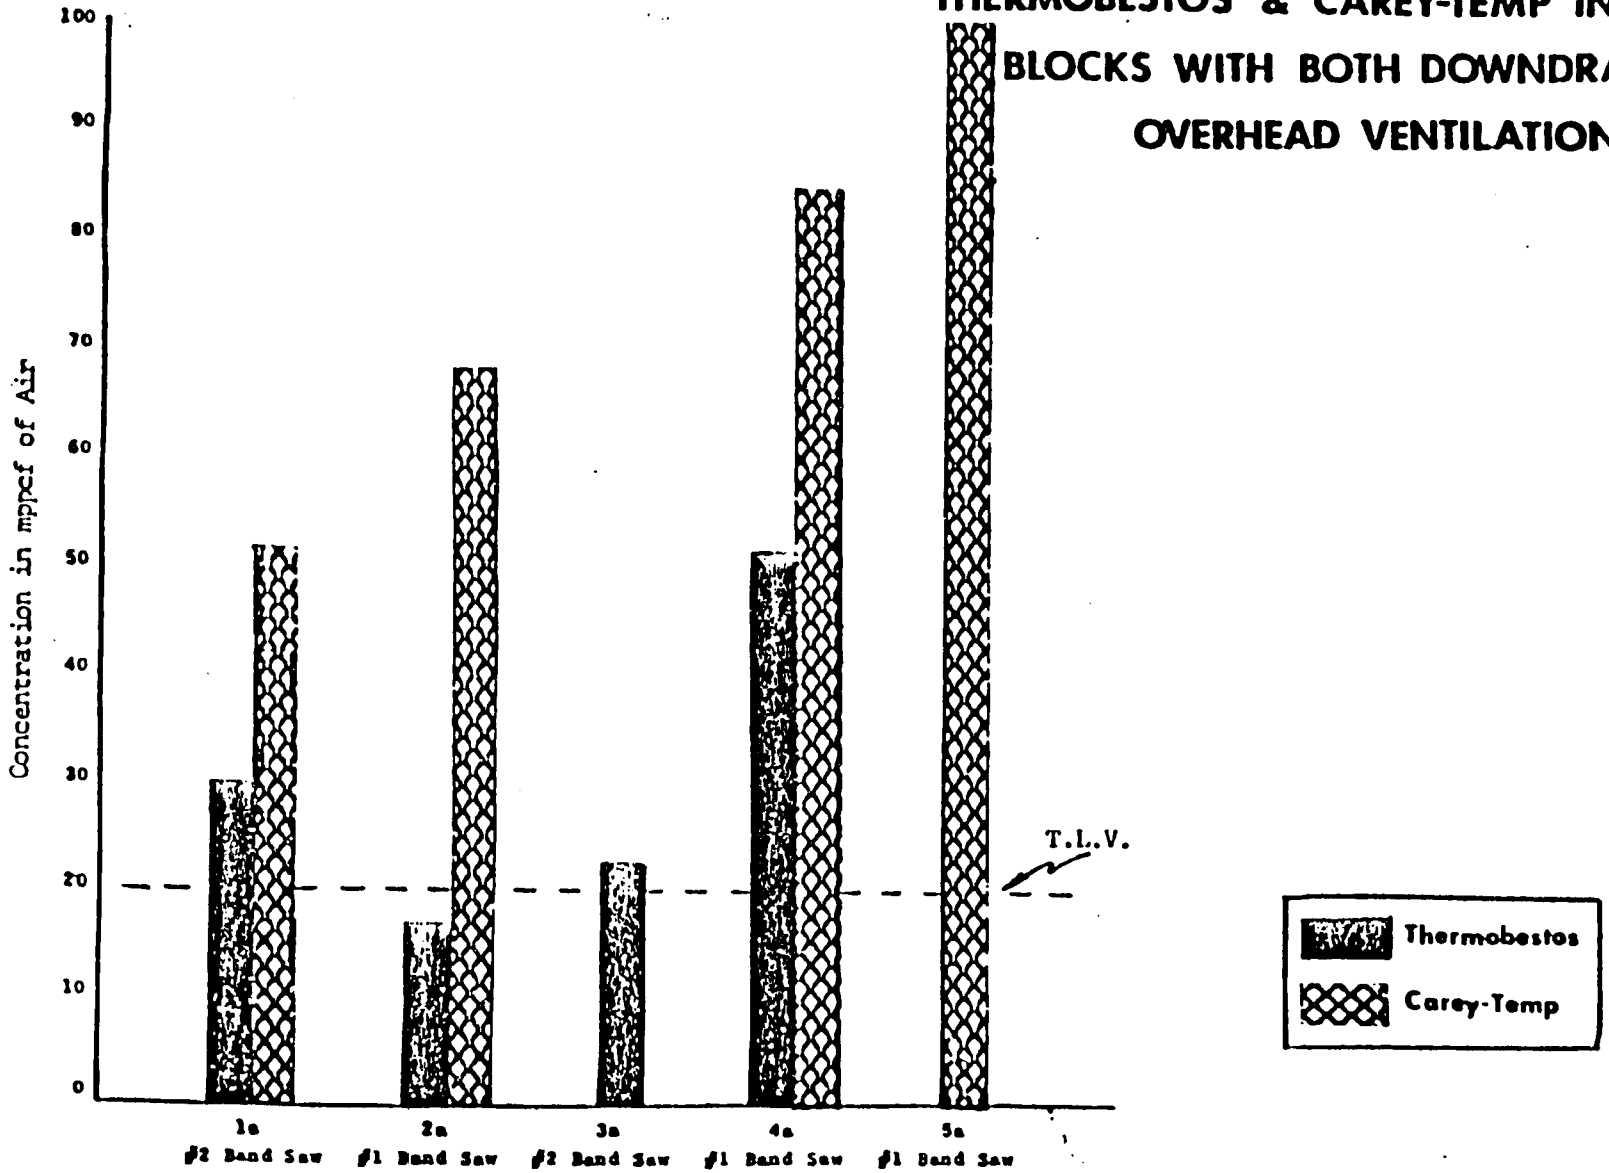
GRAPH NO. 3

From Graph #3 & Table on Page 9:

1. "Carey-Temp" dust concentrations for each exposure was substantially greater than the comparable "Thermobestos" dust concentrations and in excess of even the most lenient TLV established for human exposures, i.e., 50 mppcf of air.

2. The existing exhaust ventilation system as installed on both band saws is incapable of reducing the dust hazard, associated with the fabrication of "Carey-Temp", to within safe acceptable limits, i.e., 20 mppcf of air.

DUST EXPOSURES WHILE FABRICATING THERMOBESTOS & CAREY-TEMP INSULATIC BLOCKS WITH BOTH DOWNDRAFT AND OVERHEAD VENTILATION

1. Do not fabricate 18" x 36" x 4" "Carey-Temp" or "Thermobestos" insulation materials unless:

a. The atmospheric dust problem can be reduced to below 20 mppcf of air through the use of improved ventilation techniques or repairs to the existing system, or

b. The manufacturers of the two makes of insulation materials are able to produce a product which will not release, upon fabrication with a band saw, dust concentrations in excess of 20 mppcf of air.

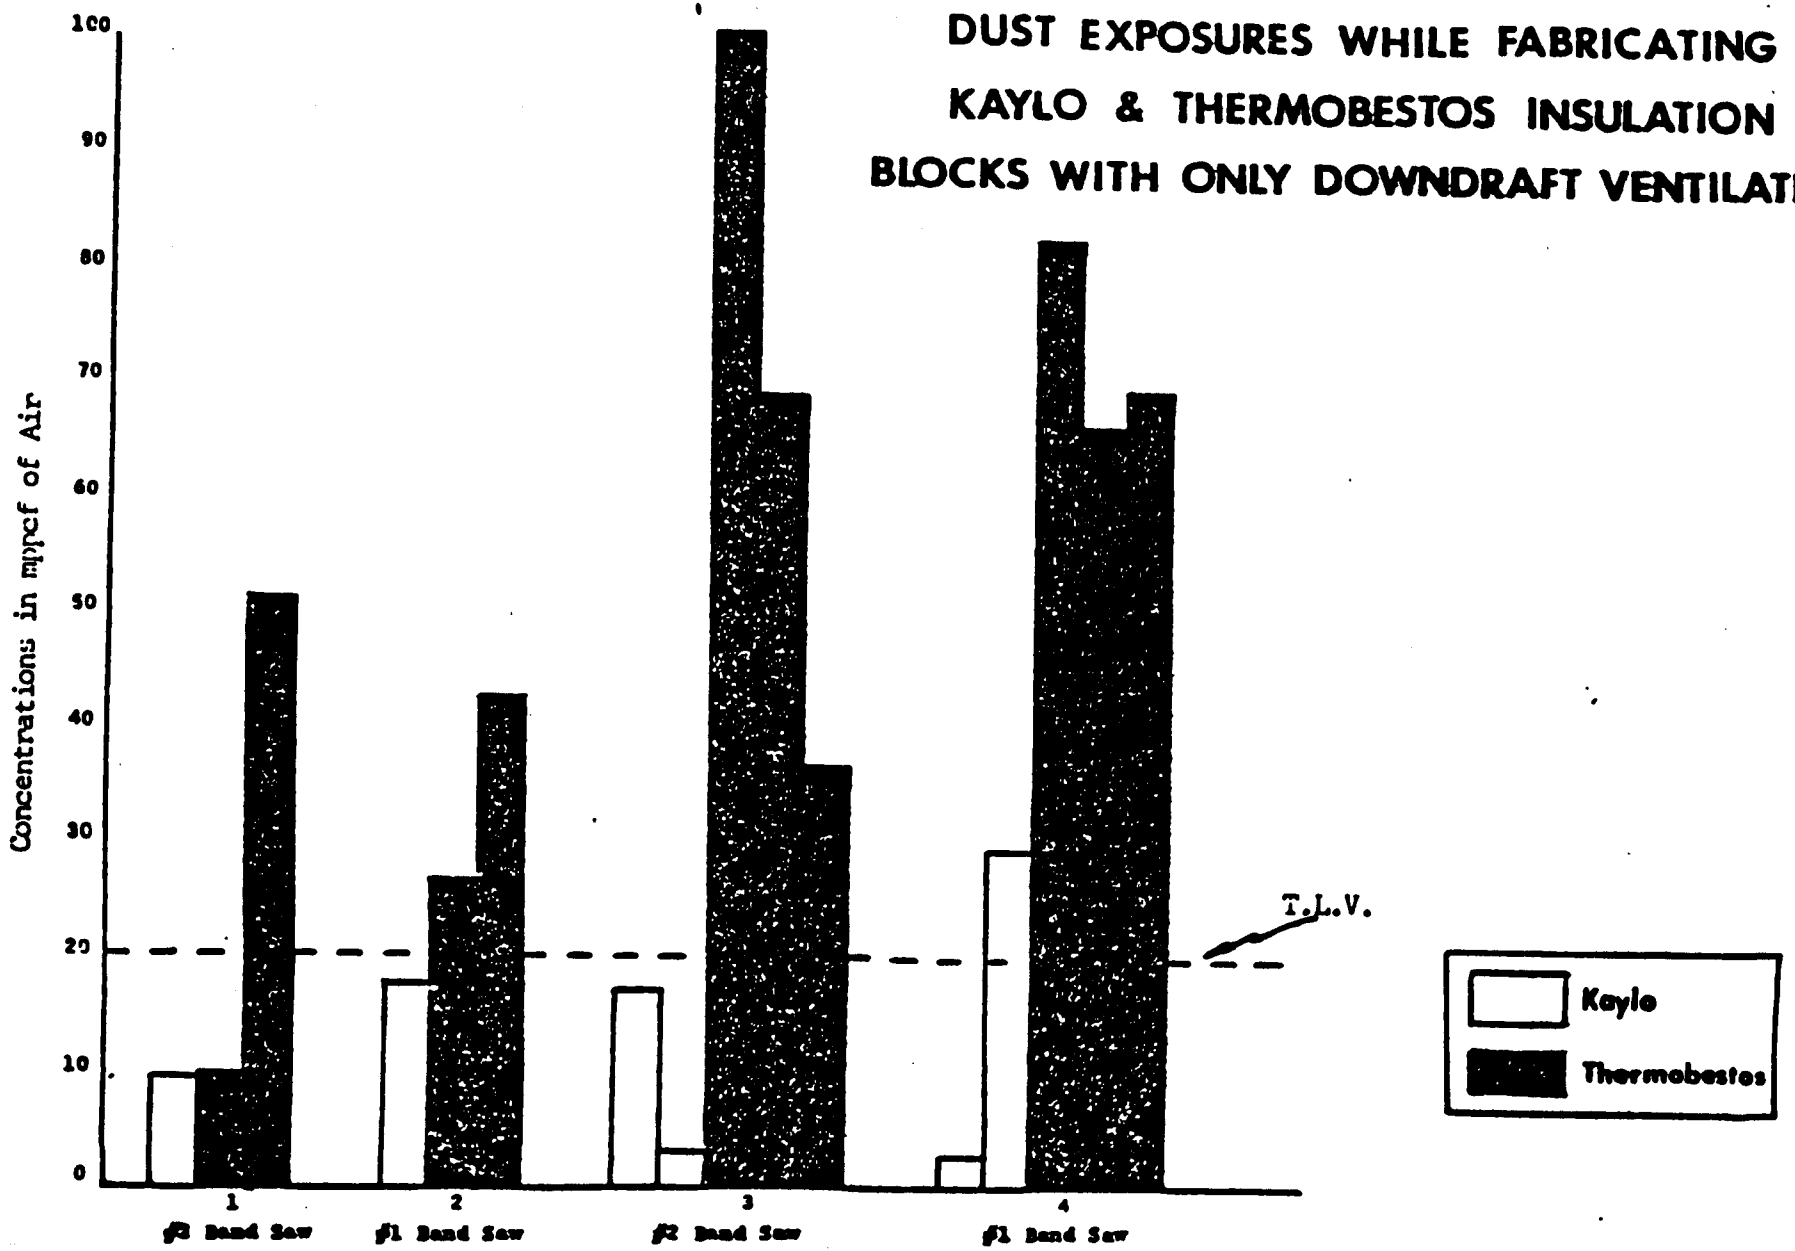
GRAPH NO. 1

2. "Kaylo" insulation blocks could be fabricated safely when using only the original downdraft exhaust ventilation if existing leaks, observed on the #1 band saw, are corrected.

DUST EXPOSURES WHILE FABRICATING KAYLO & THERMOBESTOS INSULATION BLOCKS WITH ONLY DOWNDRAFT VENTILATION
