Subject Insulation Block Dust Survey
Construction Insulation Shop
Plant 511

INDUSTRIAL HYGIENE SURVEY

Construction Insulation Shop - Building 511-2018

Report 63-IH-3-G-1

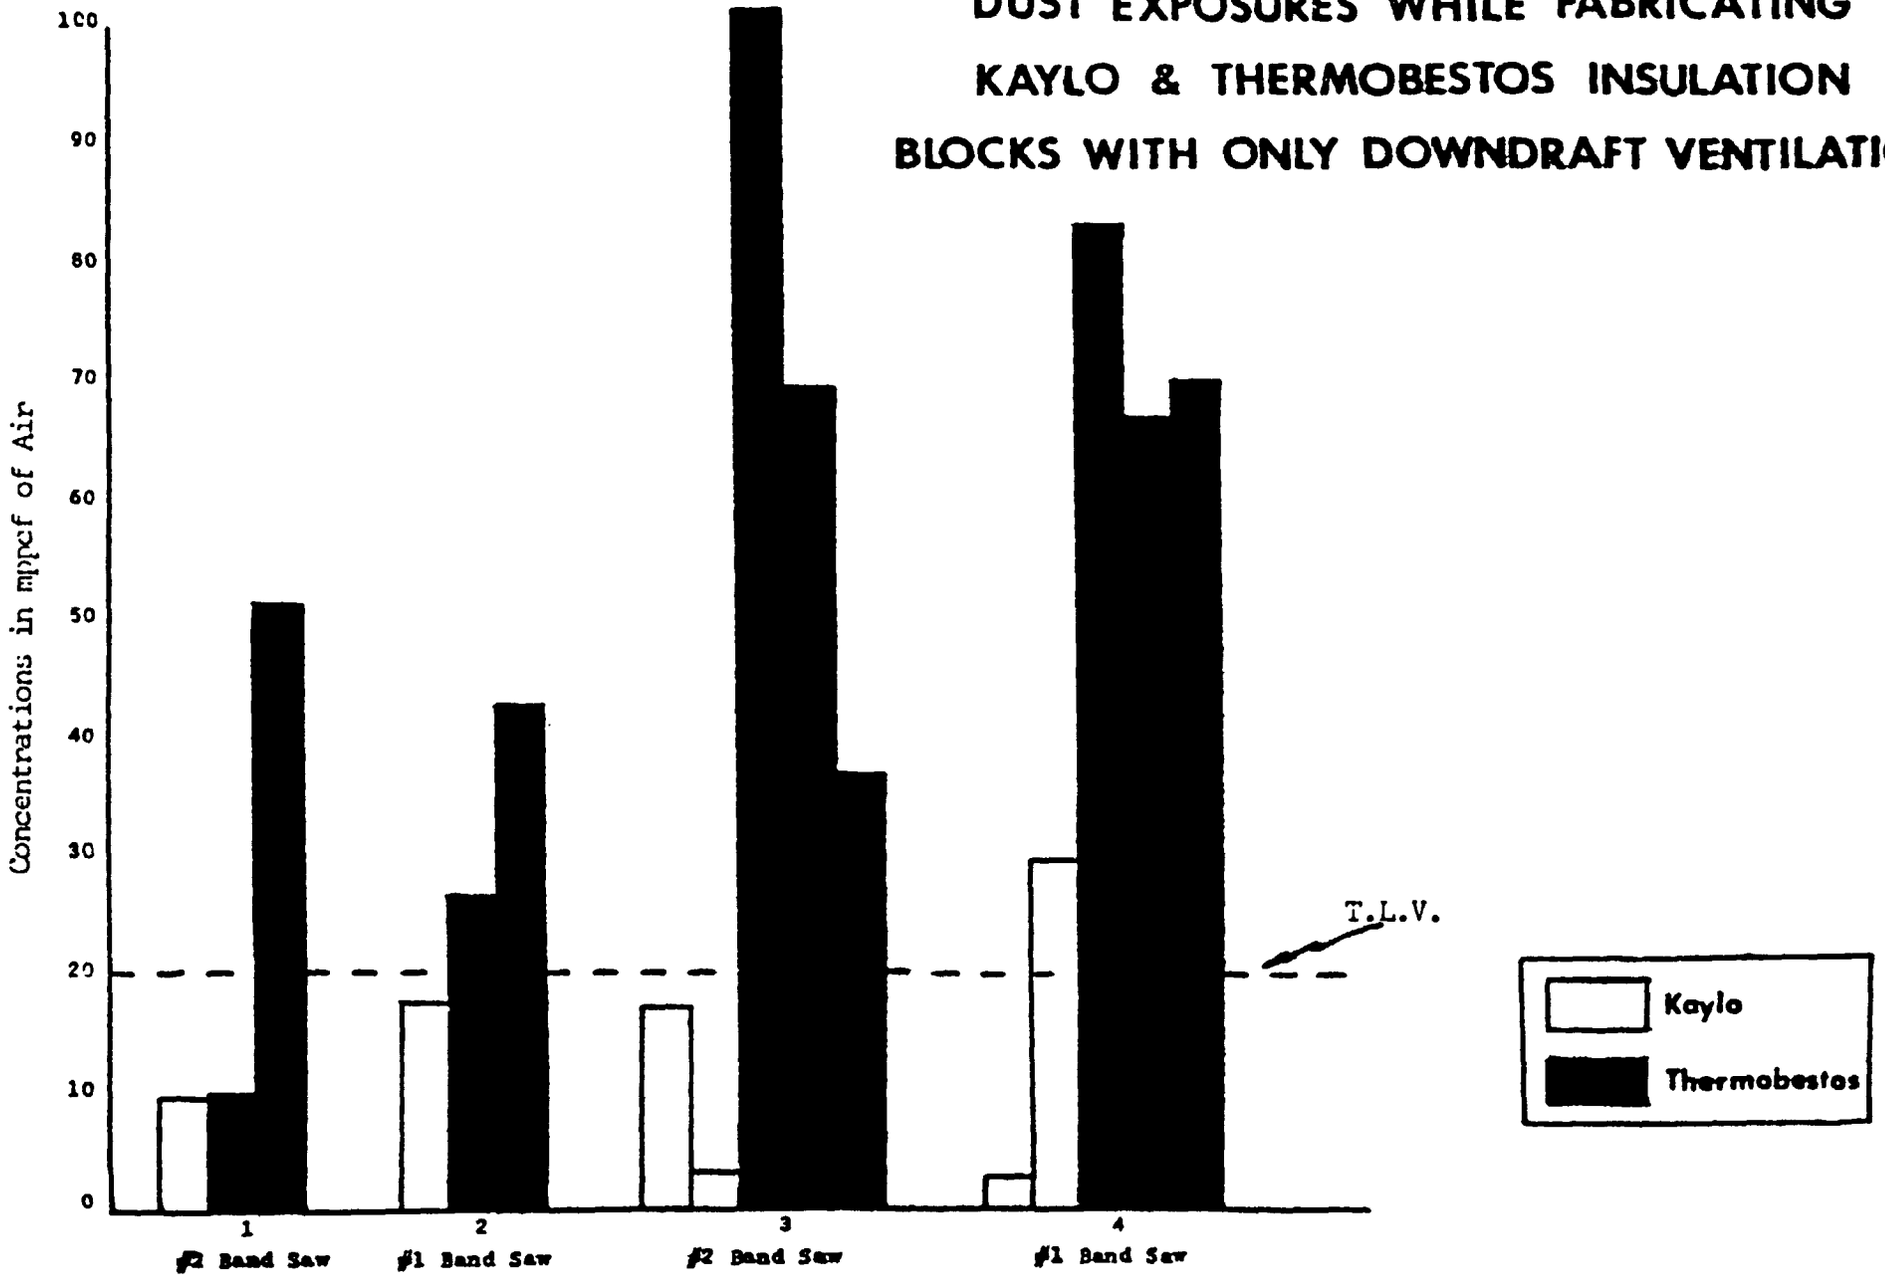
GRAPH NO. 1

1. "Thermobestos" insulation blocks should not be fabricated when using only the original downdraft exhaust ventilation.

2. "Kaylo" insulation blocks could be fabricated safely when using only the original downdraft exhaust ventilation if existing leaks, observed on the #1 band saw, are corrected.

3. "Kaylo" insulation blocks definitely may be safely fabricated when using the entire exhaust ventilation facilities now available, i.e., hoods above the blocks as well as below.

DUST EXPOSURES WHILE FABRICATING KAYLO & THERMOBESTOS INSULATION BLOCKS WITH ONLY DOWNDRAFT VENTILATIC

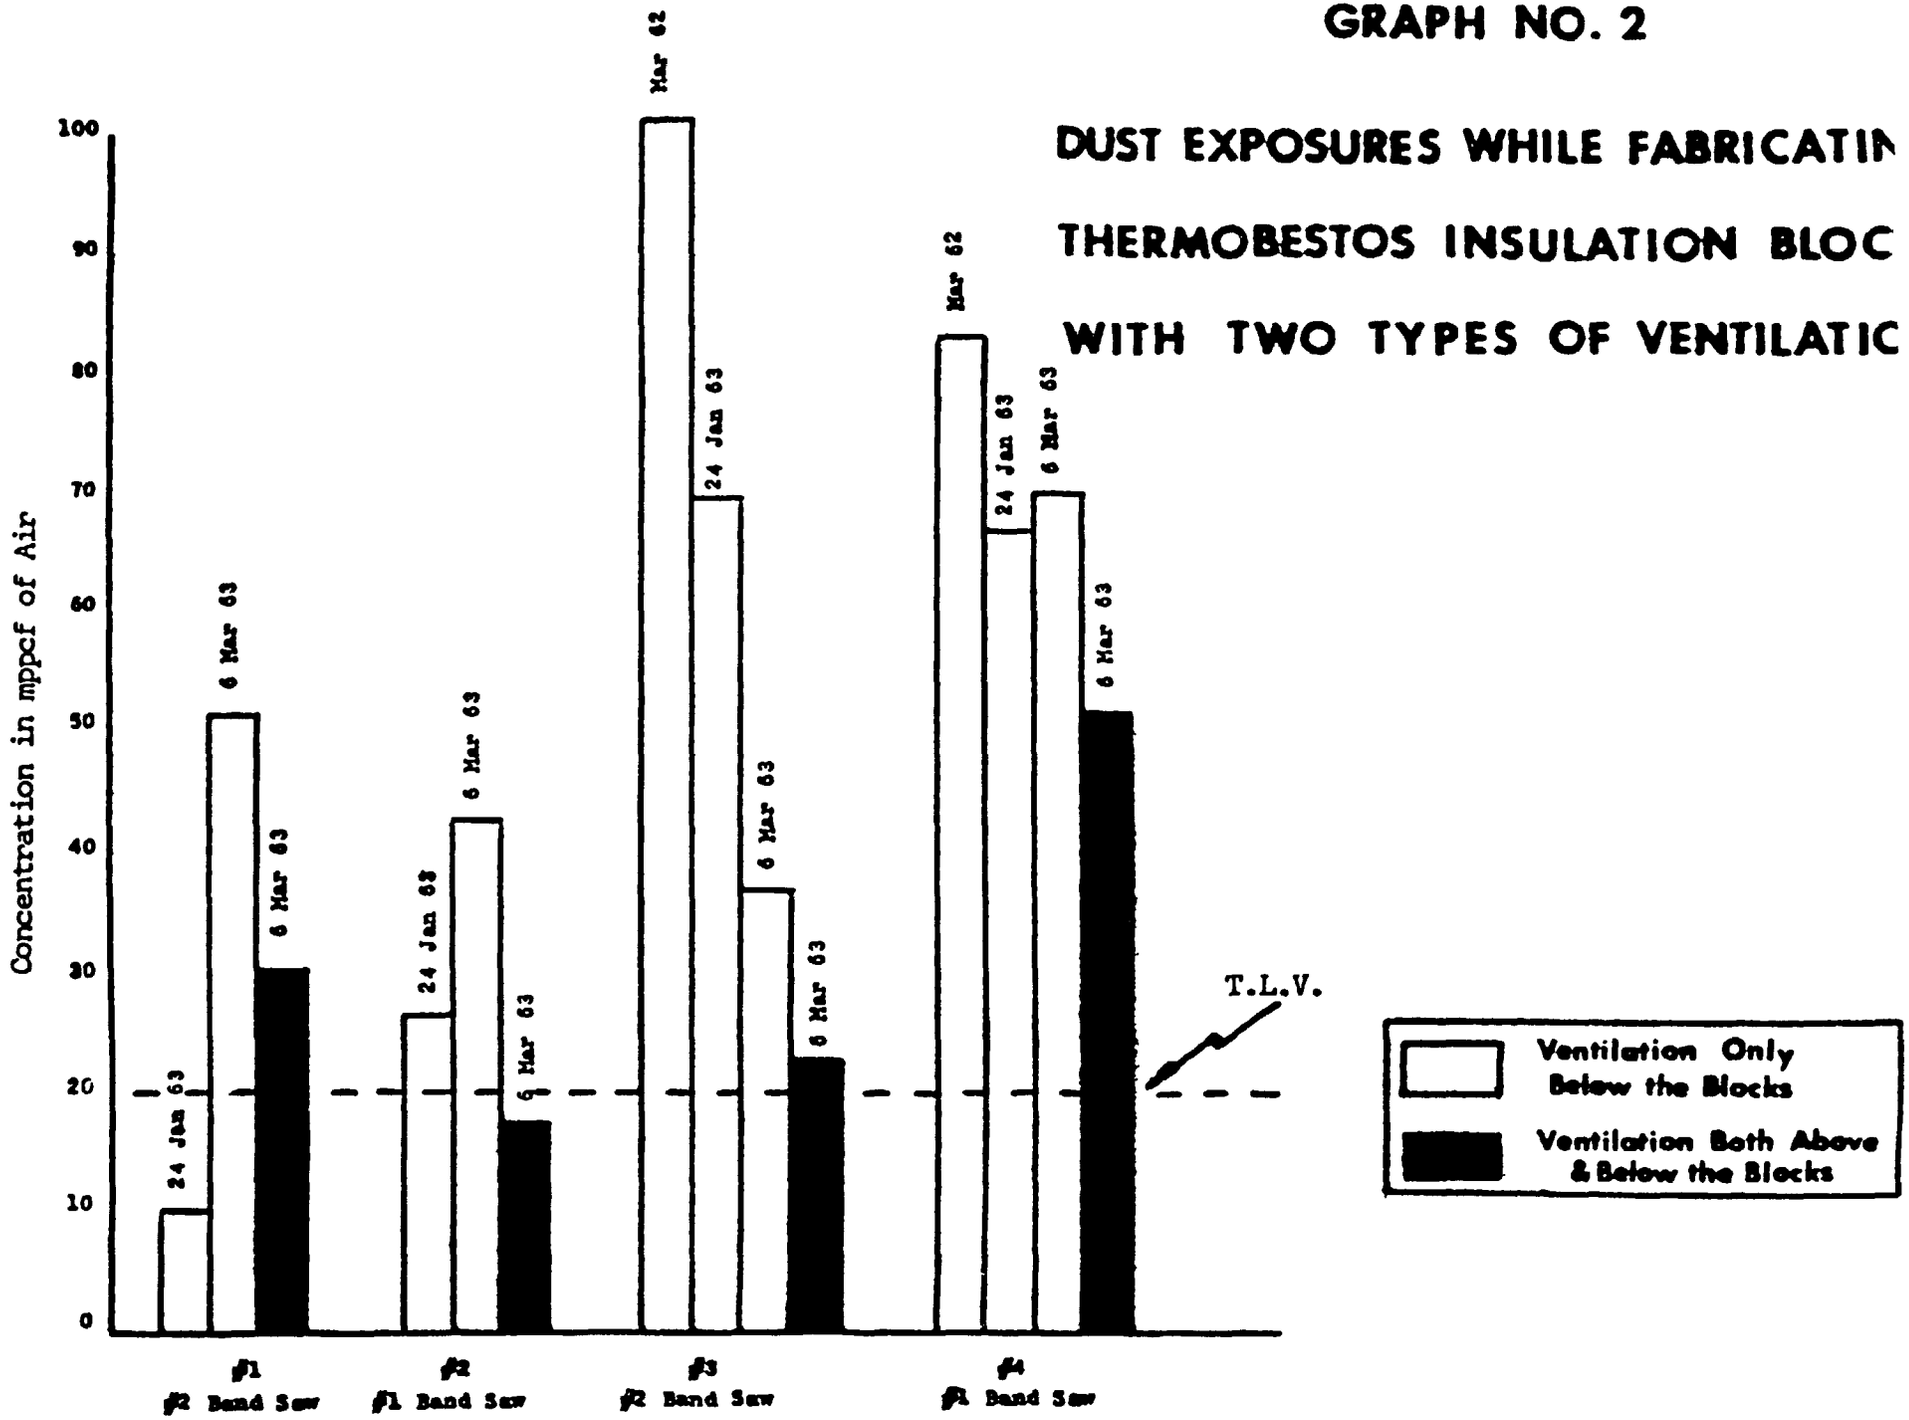
GRAPH NO. 2

1. Methods of handling "Thermobestos" blocks (preparatory to sawing) and scraps (after sawing) contribute greatly to specific individual exposures as demonstrated by the following facts:

a. The fabrication process, which always begins at the #2 band saw with the simple cutting of each 18" x 36" x 4" block into three smaller blocks about 18" x 12" x 4", is normally the least dusty of all the fabrication operations as revealed by the samples taken on 24 Jan 1963

b. However, on 6 Mar 1963, this operation was revealed as being one of the dustiest, regardless of the ventilation being used.

c. There was only one major variable between the samples taken on the two dates, i.e., the method of handling the blocks preparatory to sawing. Consideration of the procedure used on these dates reveals: (1) that on 24 Jan 1963, the blocks were rolled up to the saw after having been removed from their shipping cartons and stacked on a "dolly" for easy individual removal and (2) on 6 Mar 1963, the blocks were not removed from their shipping cartons until needed by the worker. A large amount of dust is produced when blocks are removed individually from the cartons as a result of the natural abrasion produced when one block is pulled over the surface of the other. Consequently, the dust concentrations on this date at this location were greater than normal.

2. The supplementary overhead ventilation (added since the time of the preceding two reports) does successfully reduce the dust exposures. However, it does not reduce "Thermobestos" dust exposures to within safe acceptable limits when cutting radii.

DUST EXPOSURES WHILE FABRICATIN THERMOBESTOS INSULATION BLOC WITH TWO TYPES OF VENTILATIC

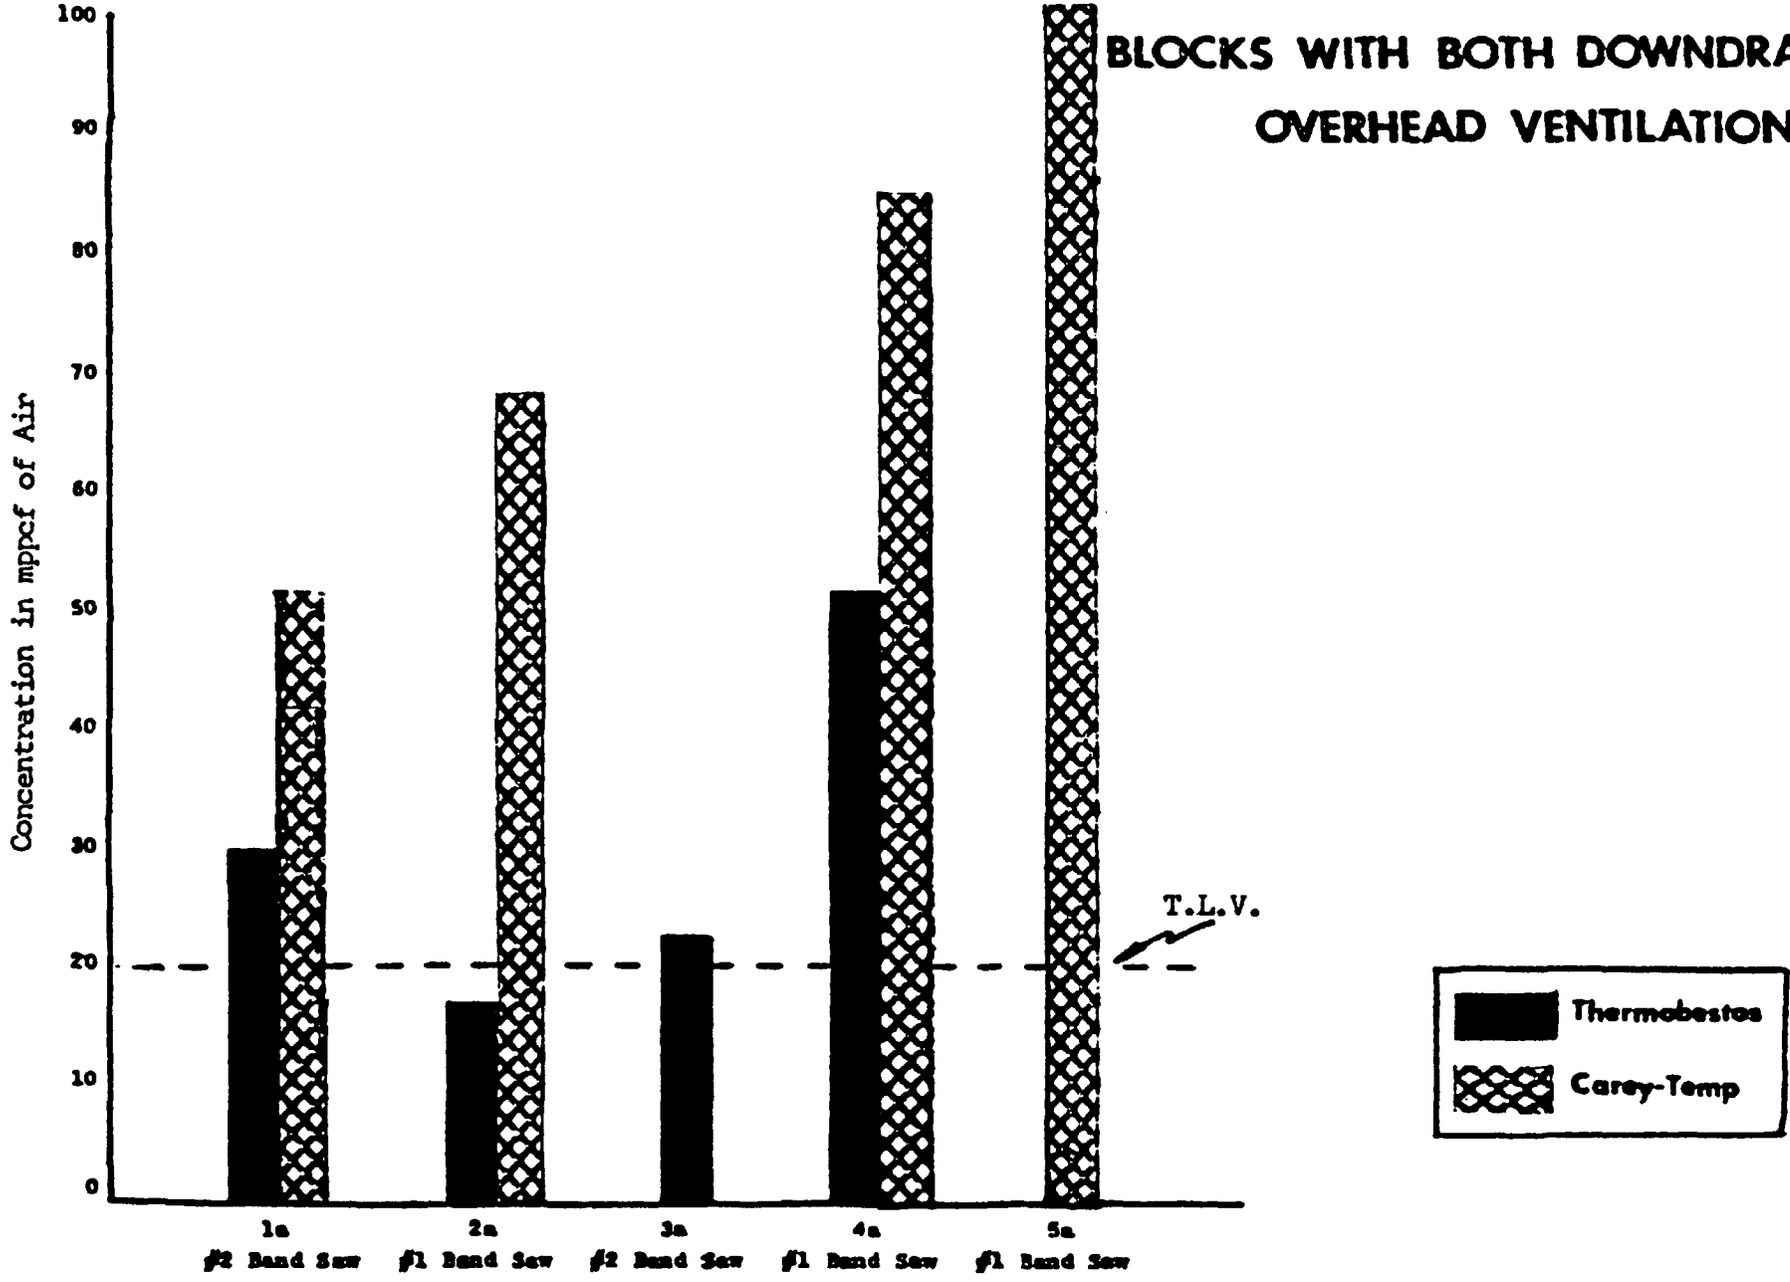
1. "Carey-Temp" dust concentrations for each exposure was substantially greater than the comparable "Thermobestos" dust concentrations and in excess of even the most lenient TLV established for human exposures, i.e., 50 mppcf of air.

2. The existing exhaust ventilation system as installed on both band saws is incapable of reducing the dust hazard, associated with the fabrication of "Carey-Temp", to within safe acceptable limits, i.e., 20 mppcf of air.

DUST EXPOSURES WHILE FABRICATING THERMOBESTOS & CAREY-TEMP INSULATIC BLOCKS WITH BOTH DOWNDRAFT ANI OVERHEAD VENTILATION

1. Do not fabricate 18" x 36" x 4" "Carey-Temp" or "Thermobestos" insulation materials unless:

a. The atmospheric dust problem can be reduced to below 20 mppcf of air through the use of improved ventilation techniques or repairs to the existing system, or

b. The manufacturers of the two makes of insulation materials are able to produce a product which will not release, upon fabrication with a band saw, dust concentrations in excess of 20 mppcf of air.
