Subject Insulation Block Dust Survey
Construction Insulation Shop
Plant 511

INDUSTRIAL HYGIENE SURVEY

Construction Insulation Shop - Building 511-2018

Report 63-IH-3-G-1

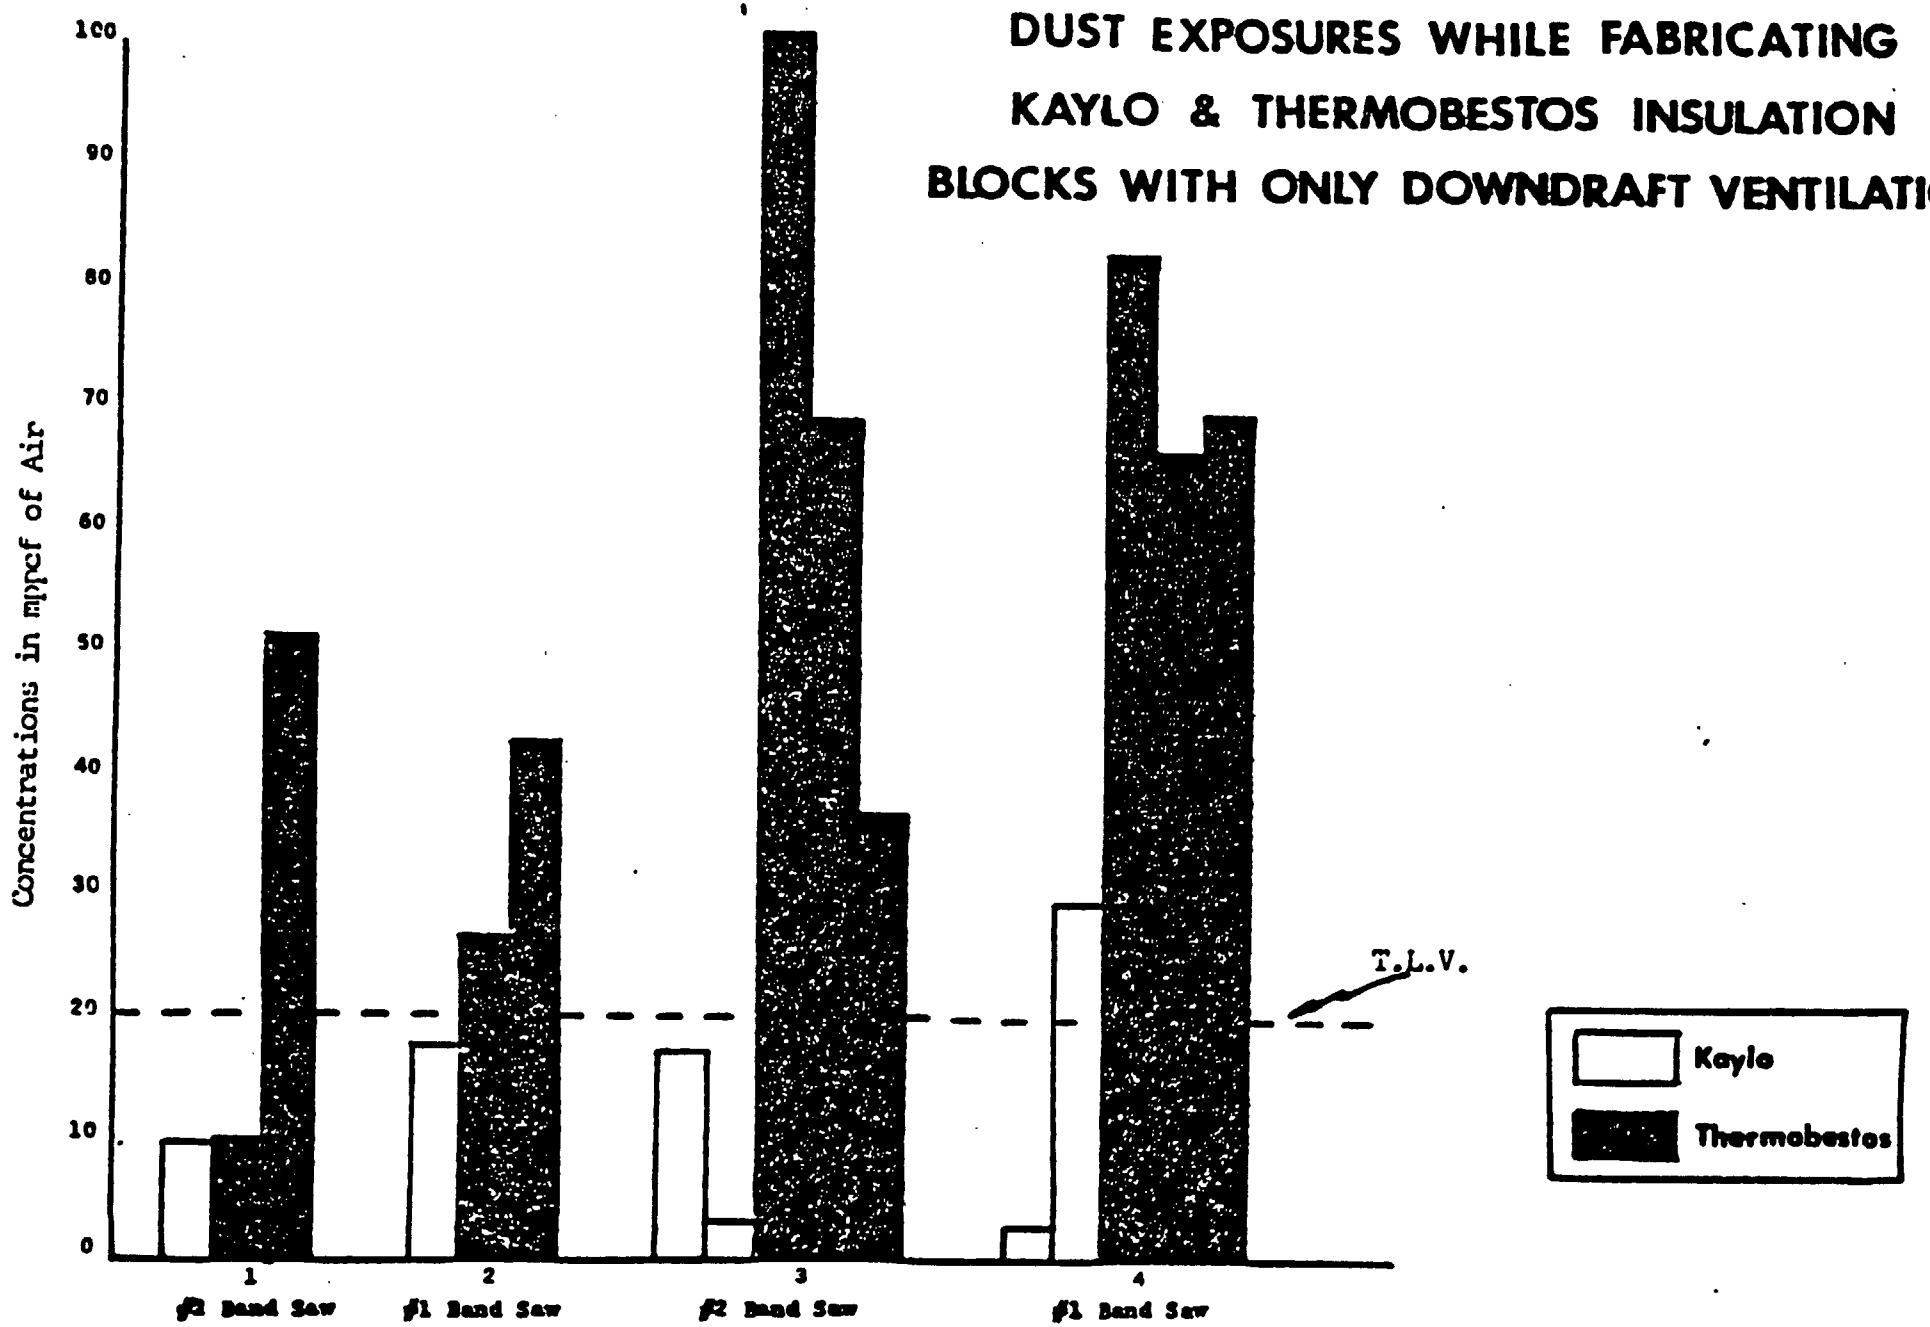
GRAPH NO. 1

Relative to dust exposures from Graph #1 & Tables on Pages 8 & 9:

1. "Thermobestos" insulation blocks should not be fabricated when using only the original downdraft exhaust ventilation.

2. "Kaylo" insulation blocks could be fabricated safely when using only the original downdraft exhaust ventilation if existing leaks, observed on the #1 band saw, are corrected.

3. "Kaylo" insulation blocks definitely may be safely fabricated when using the entire exhaust ventilation facilities now available, i.e., hoods above the blocks as well as below.

DUST EXPOSURES WHILE FABRICATING KAYLO & THERMOBESTOS INSULATION BLOCKS WITH ONLY DOWNDRAFT VENTILATION

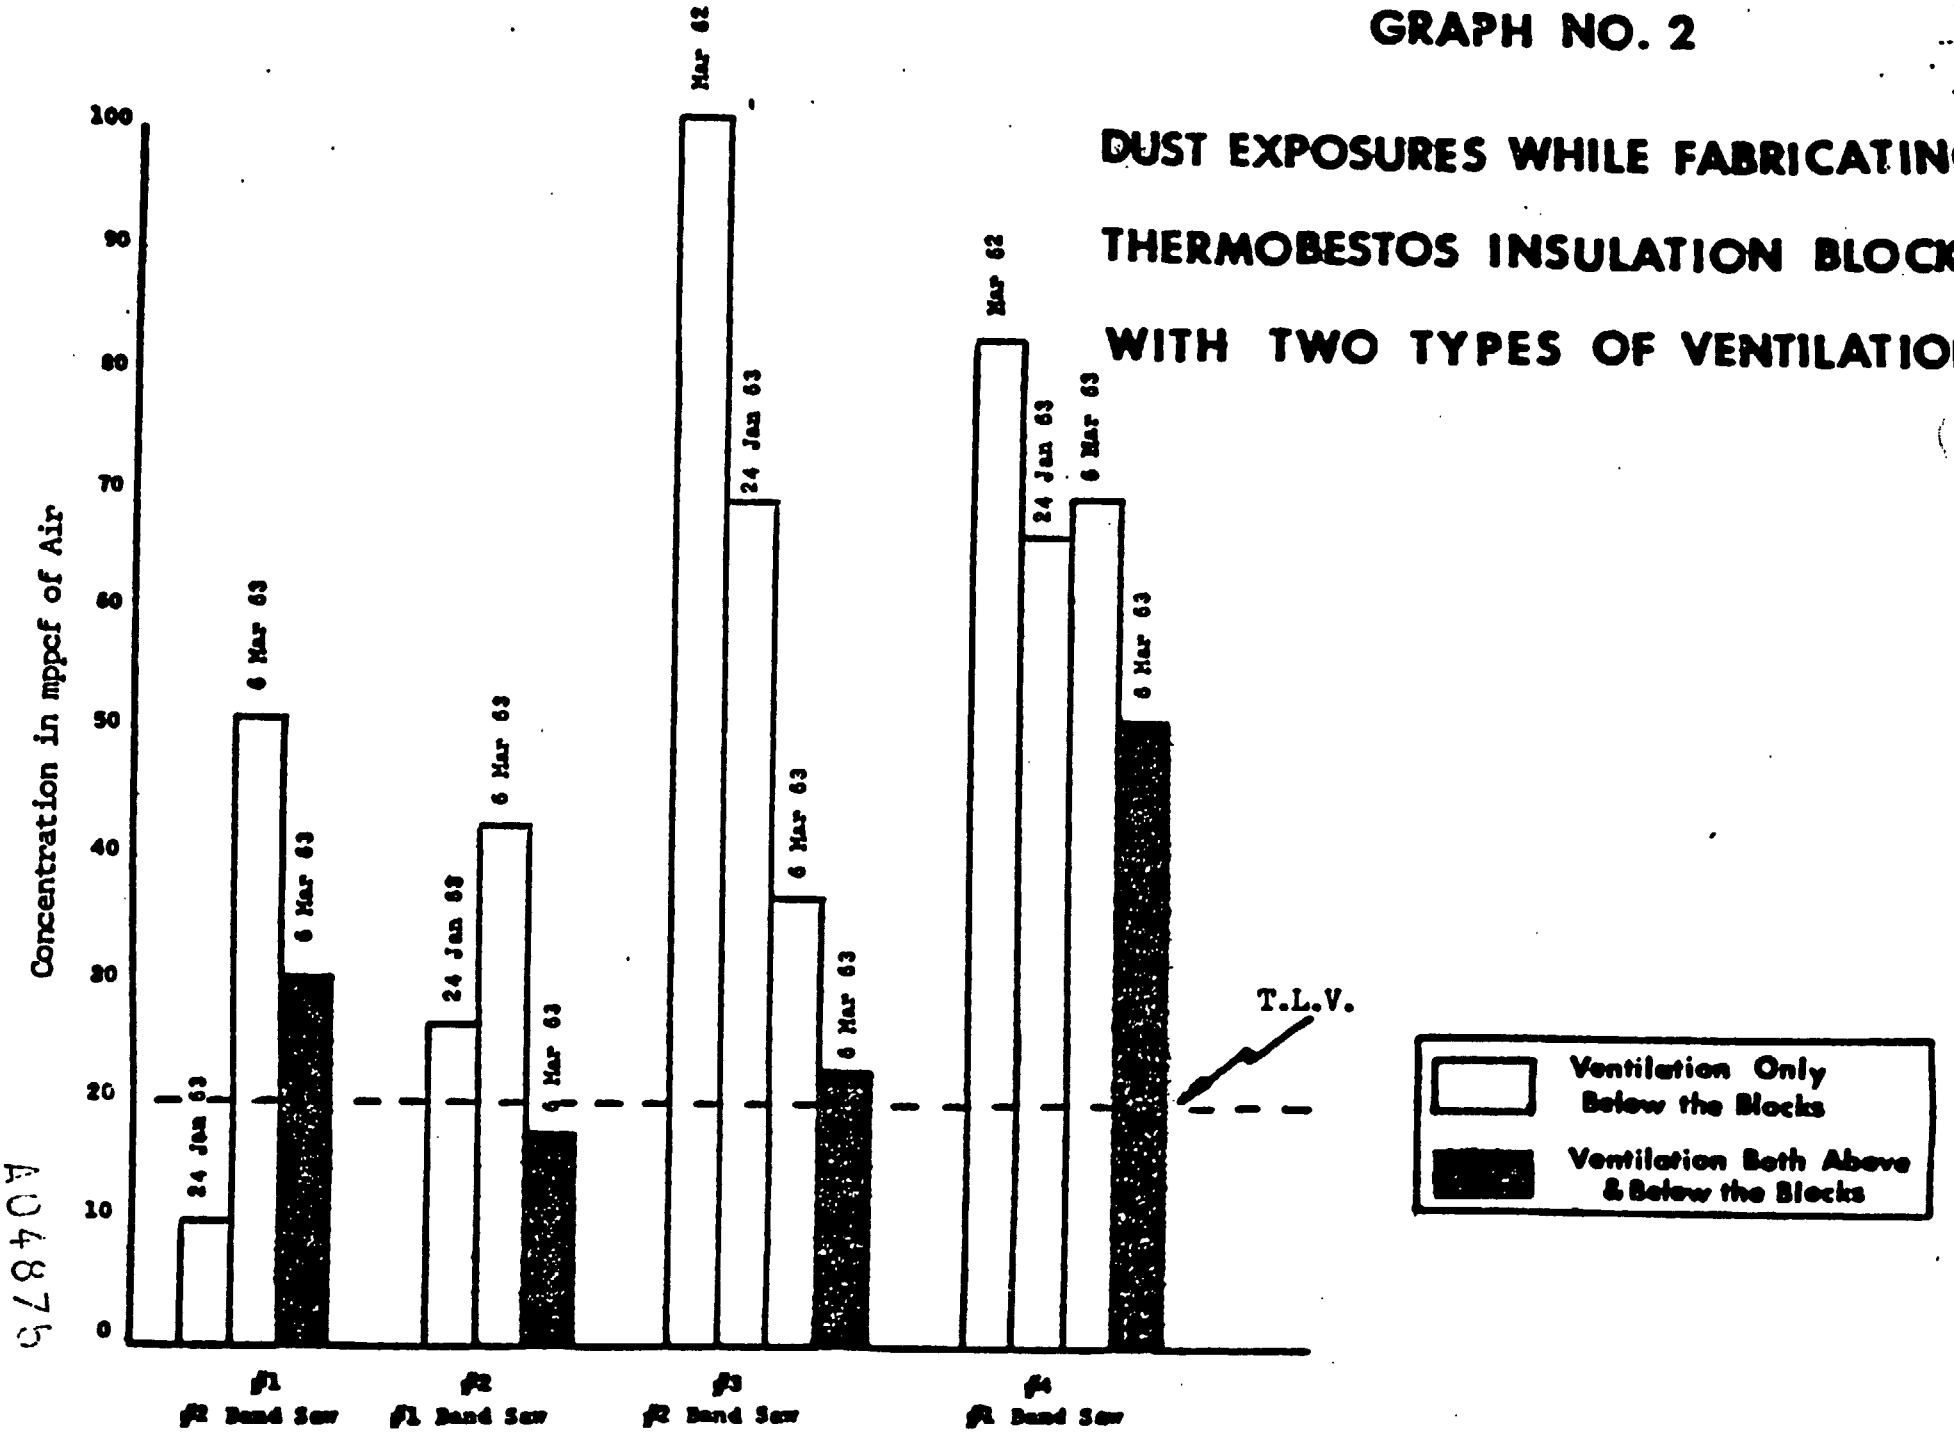
GRAPH NO. 2

From Graph #2 & Tables on Pages 8 & 9:

1. Methods of handling "Thermobestos" blocks (preparatory to sawing) and scraps (after sawing) contribute greatly to specific individual exposures as demonstrated by the following facts:

2. The supplementary overhead ventilation (added since the time of the preceding two reports) does successfully reduce the dust exposures. However, it does not reduce "Thermobestos" dust exposures to within safe acceptable limits when cutting radii.

DUST EXPOSURES WHILE FABRICATING THERMOBESTOS INSULATION BLOCKS WITH TWO TYPES OF VENTILATION

1. Do not fabricate 18" x 36" x 4" "Carey-Temp" or "Thermobestos" insulation materials unless:

a. The atmospheric dust problem can be reduced to below 20 mppcf of air through the use of improved ventilation techniques or repairs to the existing system, or

b. The manufacturers of the two makes of insulation materials are able to produce a product which will not release, upon fabrication with a band saw, dust concentrations in excess of 20 mppcf of air.
