Union Carbide trial exhibit UC-1421: R. E. Peele, Industrial Hygiene Survey of Atmospheric Dust at the Construction… Published by AsbestosClaims.Law
ACL Doc 16554 · Page 1 of 9 asbestosclaims.law/library/16554/1

INDUSTRIAL HYGIENE SURVEY
Evaluation of Atmospheric Dust Conditions at the Construction Insulation Shop
Table #1
Atmospheric Dust Concentration Data
Collected When Using Only Partial
Ventilation, i.e., Only Below the Blocks

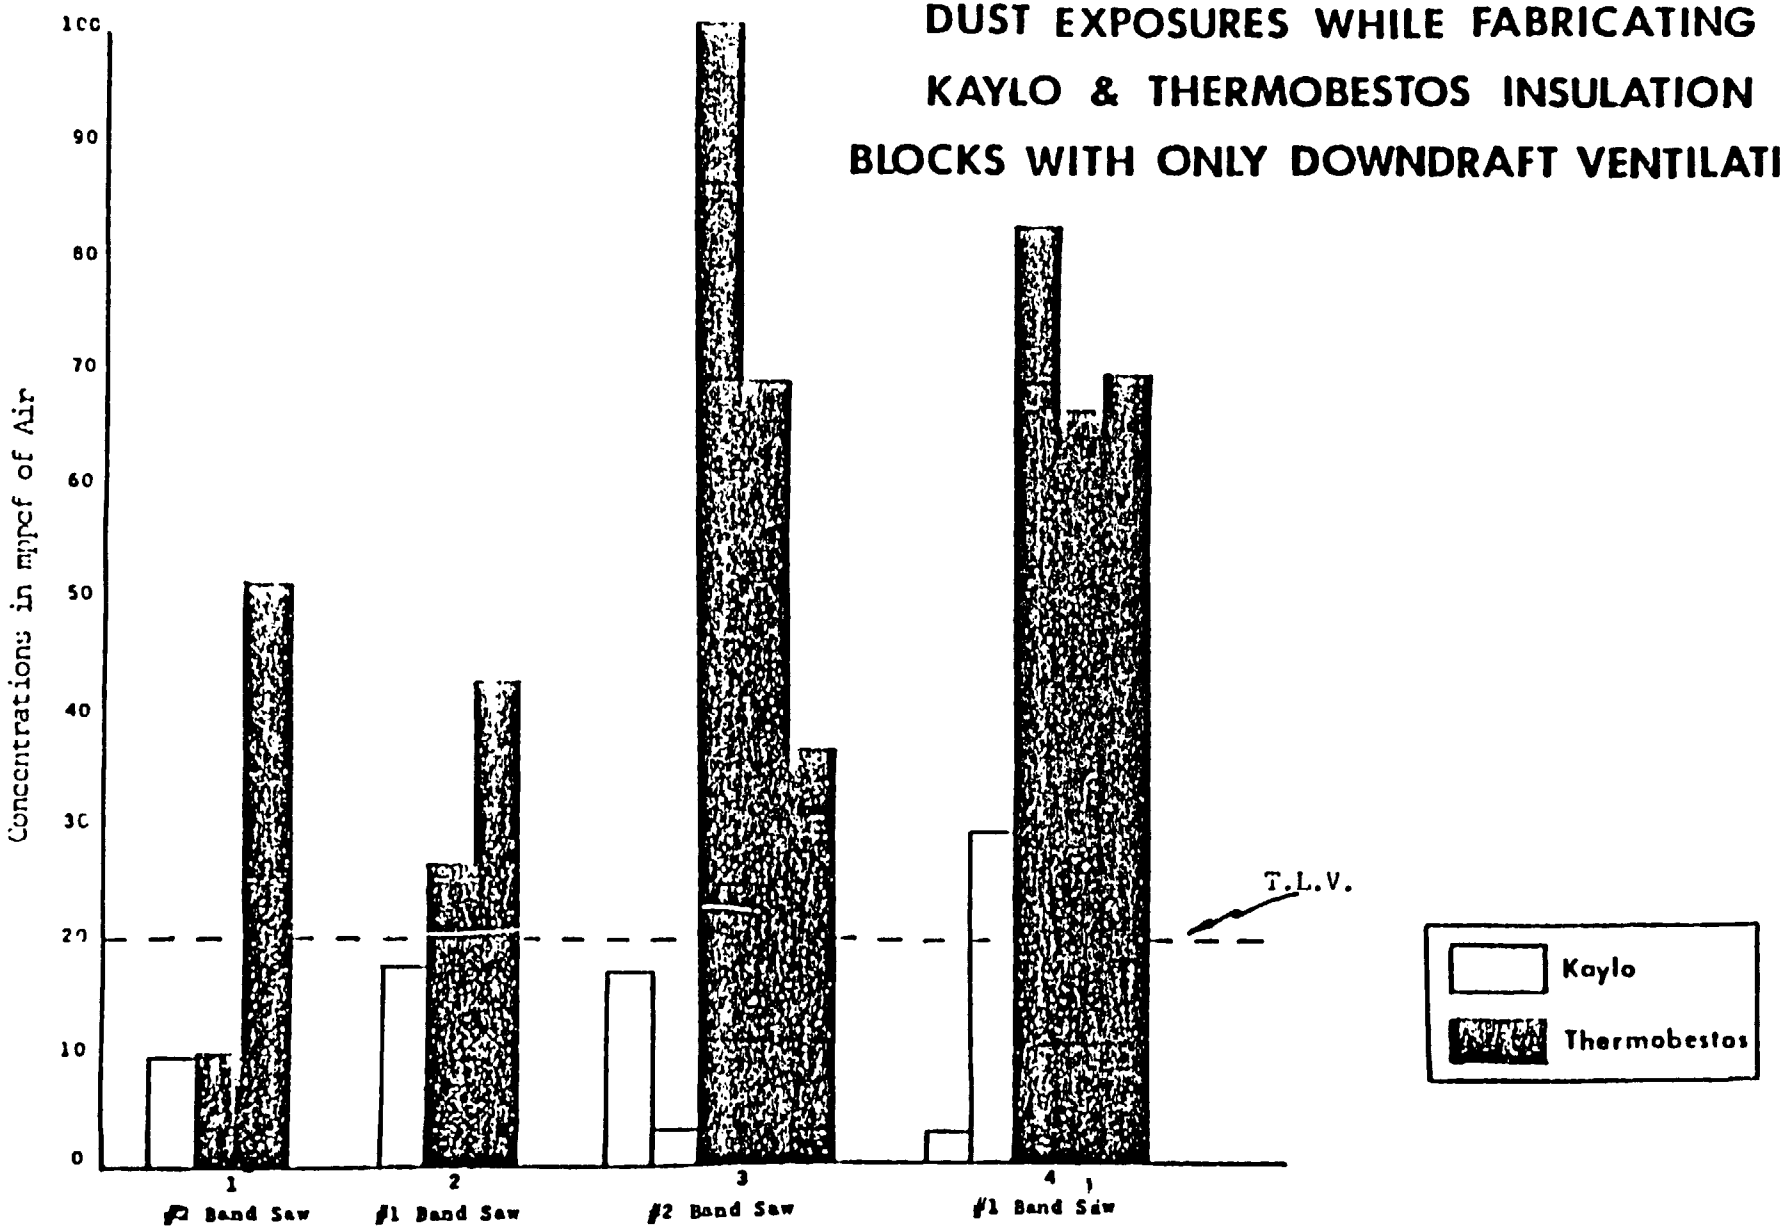
GRAPH NO. 1

Relative to dust exposures from Graph #1 & Tables on Pages 8 & 9:

1. "Thermobestos" insulation blocks should not be fabricated when using only the original downdraft exhaust ventilation.

2. "Kaylo" insulation blocks could be fabricated safely when using only the original downdraft exhaust ventilation if existing leaks, observed on the #1 band saw, are corrected.

3. "Kaylo" insulation blocks definitely may be safely fabricated when using the entire exhaust ventilation facilities now available, i.e., hoods above the blocks as well as below.

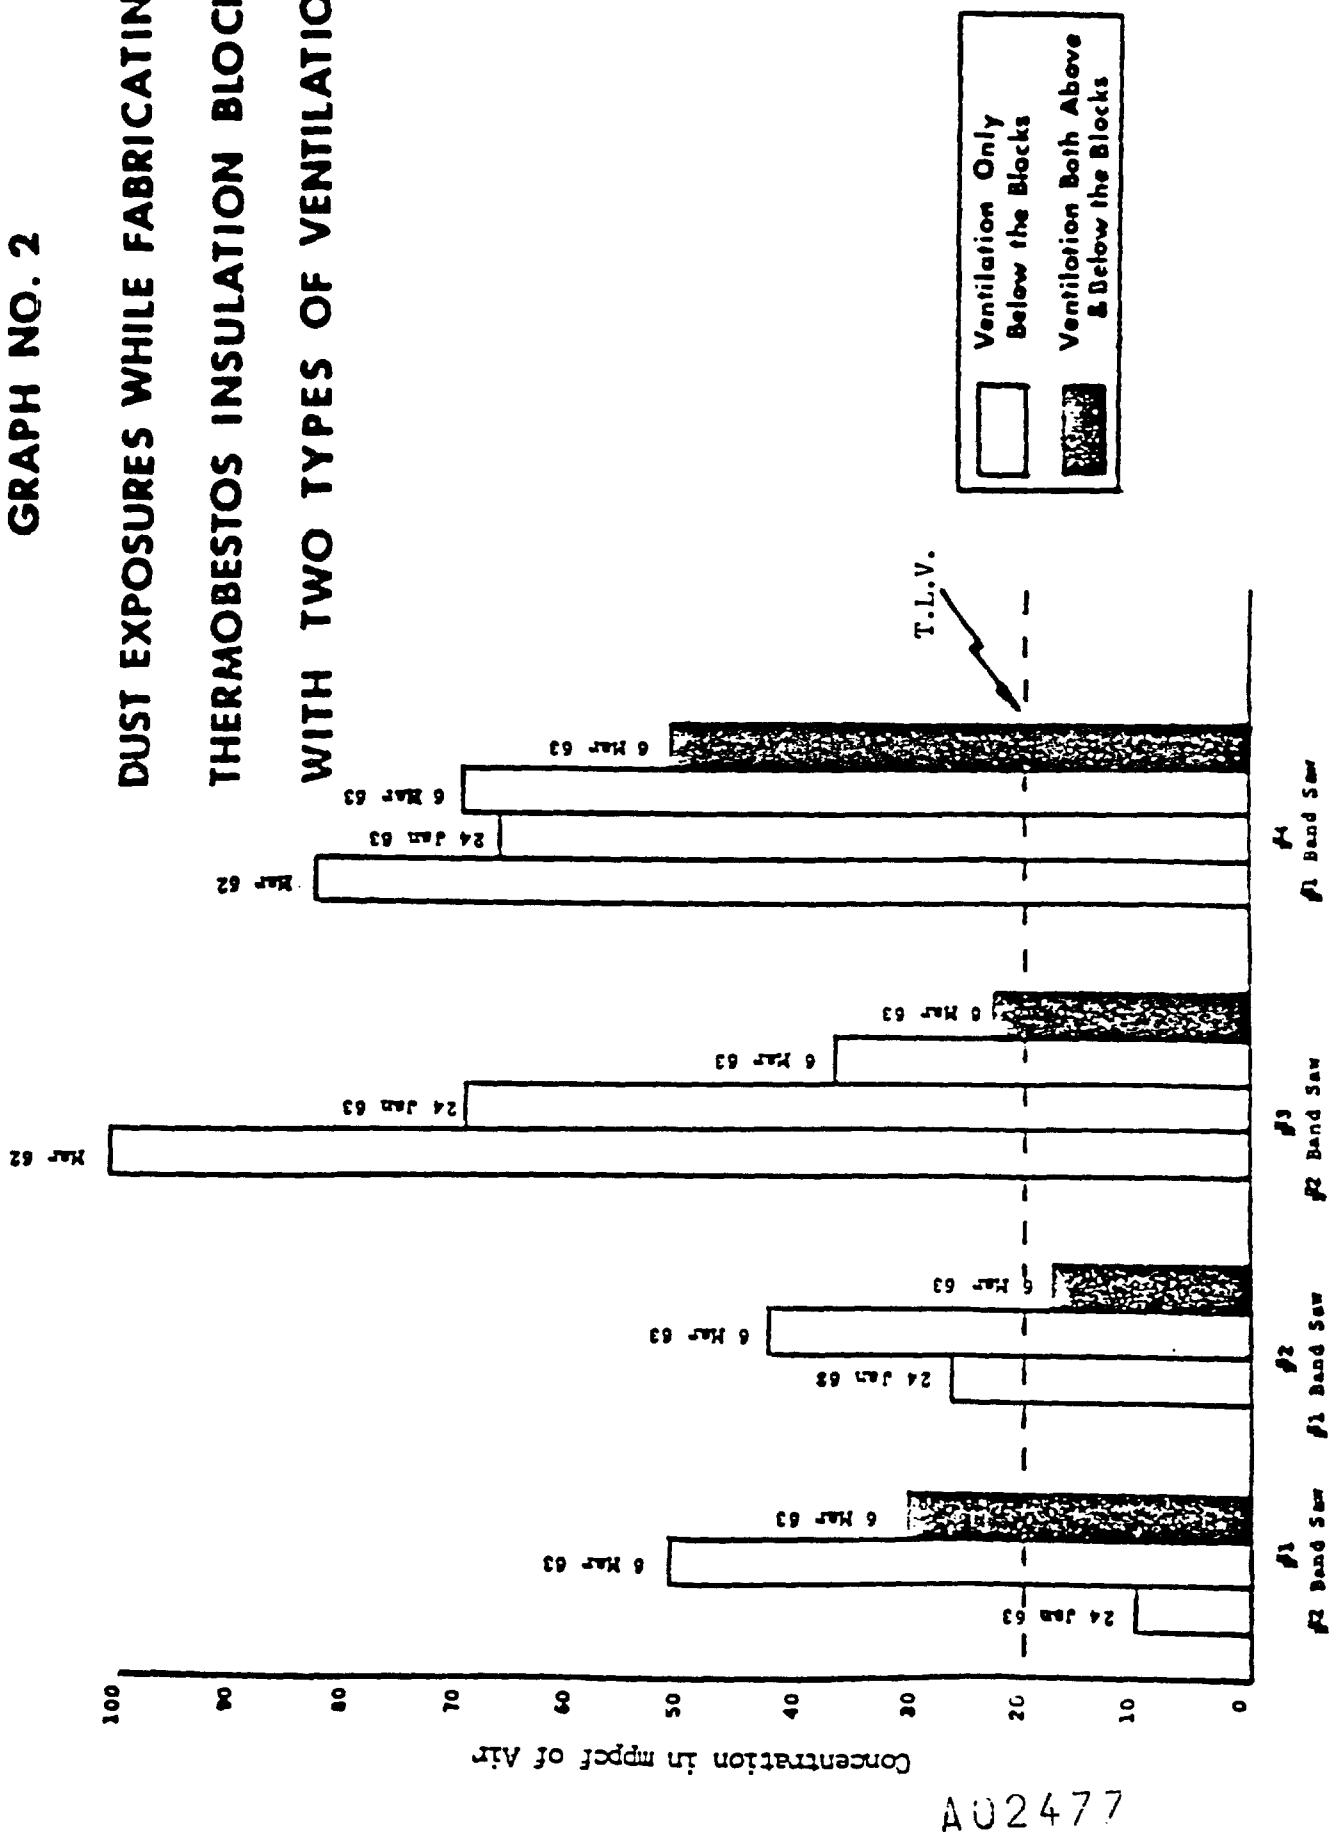
GRAPH NO. 2

From Graph #2 & Tables on Pages 8 & 9:

1. Methods of handling "Thermobestos" blocks (preparatory to sawing) and scraps (after sawing) contribute greatly to specific individual exposures as demonstrated by the following facts:

a. The fabrication process, which always begins at the #2 band saw with the simple cutting of each 18" x 36" x 4" block into three smaller blocks about 18" x 12" x 4", is normally the least dusty of all the fabrication operations as revealed by the samples taken on 24 Jan 1963.

b. However, on 6 Mar 1963, this operation was revealed as being one of the dustiest, regardless of the ventilation being used.

c. There was only one major variable between the samples taken on the two dates, i.e., the method of handling the blocks preparatory to sawing. Consideration of the procedure used on these dates reveals: (1) that on 24 Jan 1963, the blocks were rolled up to the saw after having been removed from their shipping cartons and stacked on a "dolly" for easy individual removal and (2) on 6 Mar 1963, the blocks were not removed from their shipping cartons until needed by the worker. A large amount of dust is produced when blocks are removed individually from the cartons as a result of the natural abrasion produced when one block is pulled over the surface of the other. Consequently, the dust concentrations on this date at this location were greater than normal.

2. The supplementary overhead ventilation (added since the time of the preceding two reports) does successfully reduce the dust exposures. However, it does not reduce "Thermobestos" dust exposures to within safe acceptable limits when cutting radii.

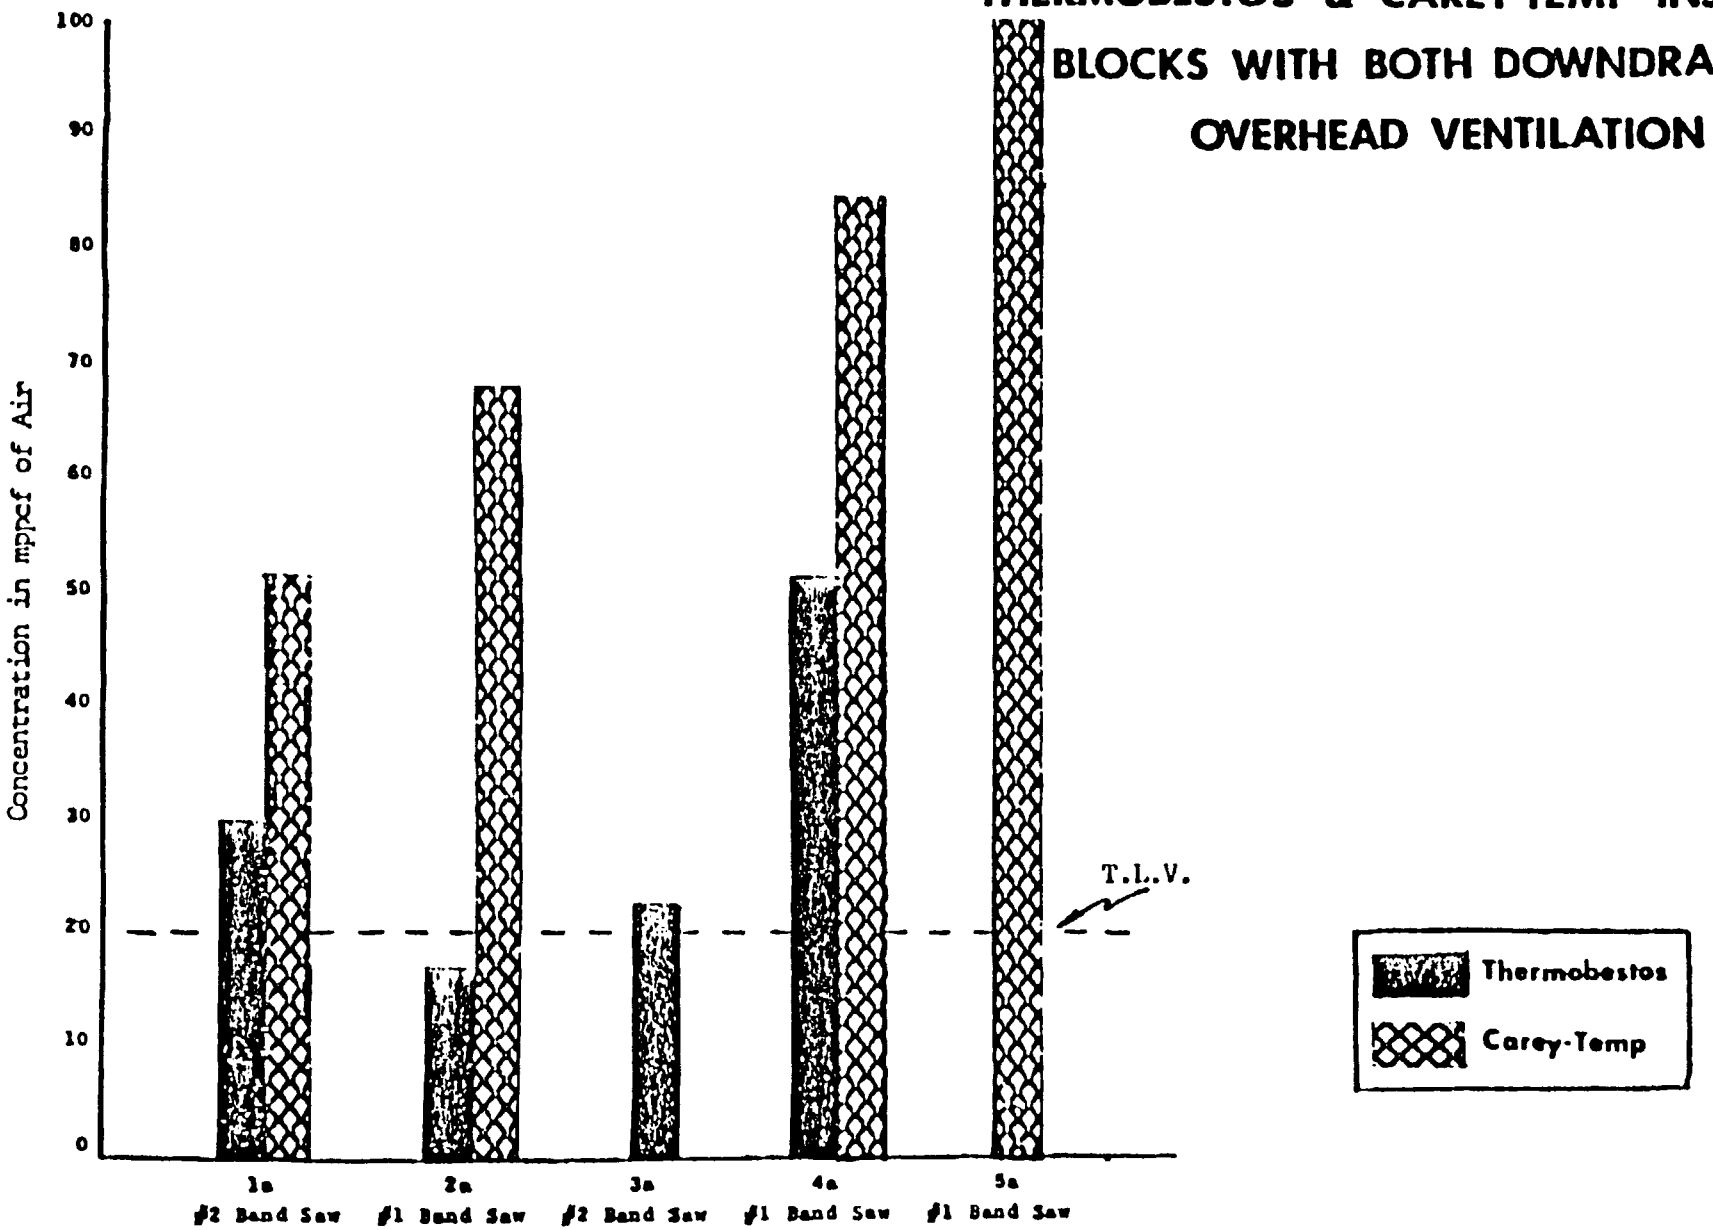
GRAPH NO. 3

From Graph #3 & Table on Page 9:

1. "Carey-Temp" dust concentrations for each exposure was substantially greater than the comparable "Thermobestos" dust concentrations and in excess of even the most lenient TLV established for human exposures, i.e., 50 mppcf of air.

2. The existing exhaust ventilation system as installed on both band saws is incapable of reducing the dust hazard, associated with the fabrication of "Carey-Temp", to within safe acceptable limits, i.e., 20 mppcf of air.

1. Do not fabricate 18" x 36" x 4" "Carey-Temp" or "Thermobestos" insulation materials unless:

a. The atmospheric dust problem can be reduced to below 20 mppcf of air through the use of improved ventilation techniques or repairs to the existing system, or

b. The manufacturers of the two makes of insulation materials are able to produce a product which will not release, upon fabrication with a band saw, dust concentrations in excess of 20 mppcf of air.
