UNION CARBIDE CORPORATION
P. O. BOX 8004, SOUTH CHARLESTON, W. VA. 25303
Silicones and Urethane Intermediates
South Charleston Plant

PLAINTIFF'S EXHIBIT
UC-2290

ASBESTOS ESTIMATE

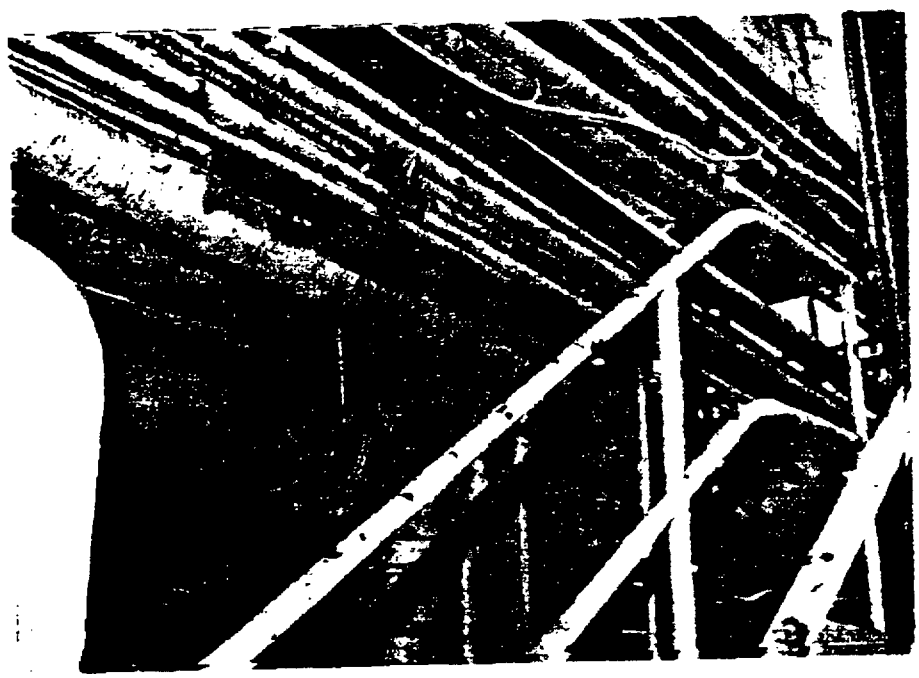
PICTURE: Left

DISCRIPTION: Unused line at stairway on the N/W corner of bldg. 195.

COLOR CODED: Red
MANHOURS REQUIRED: 24
PRIORITY: 1
