INDUSTRIAL HYGIENE SURVEY

Construction Insulation Shop - Building 811-2019

Report 63-IH-3-G-1

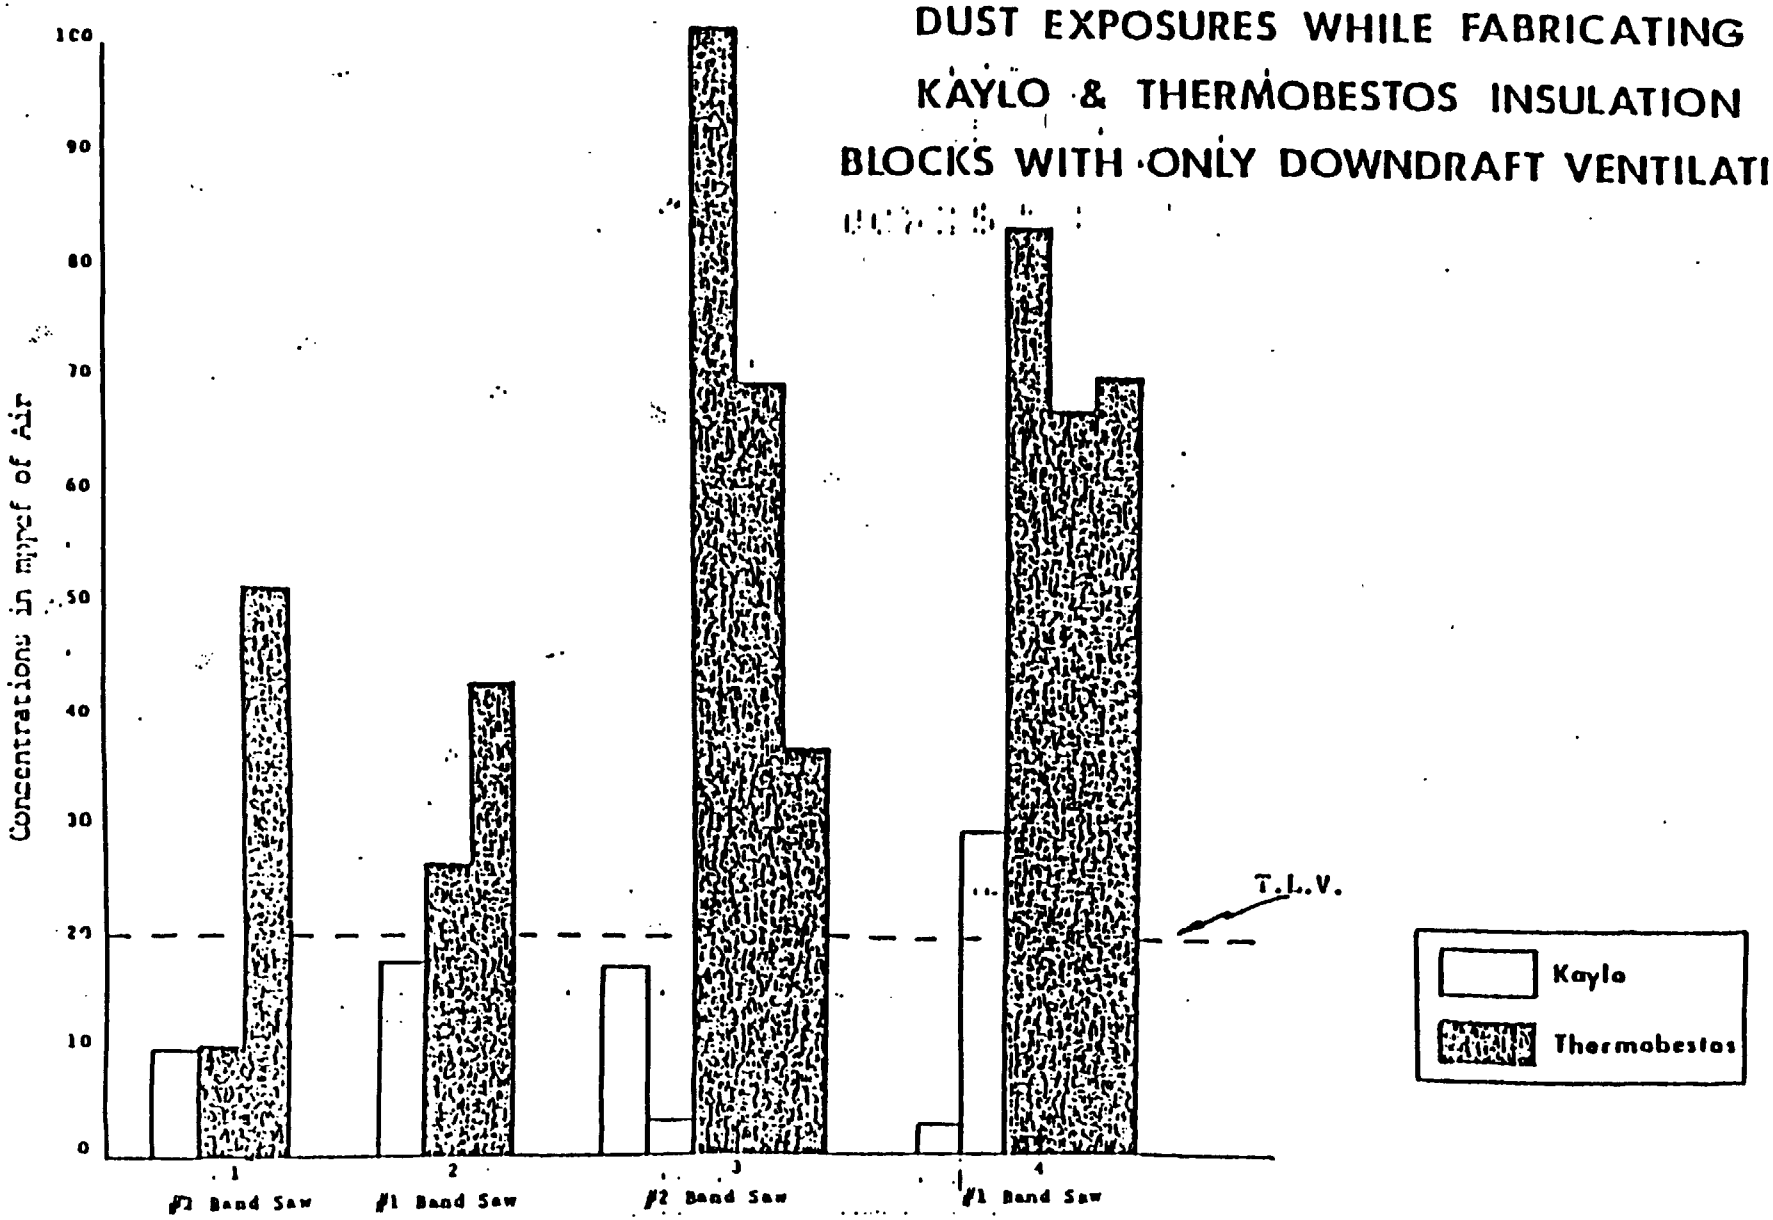
Table #4
Ventilation Rates on Two Band Saws

1. The duct velocity in the downdraft ventilation system on both band saws is far below the recommended value of 4000 fpm.

2. The duct velocity in the overhead ventilation system on both band saws is equal to or more than the recommended value of 4000 fpm.

3. The velocity in the downdraft ventilation systems for both band saws could be increased by patching all holes, leaks, etc., now in existence.

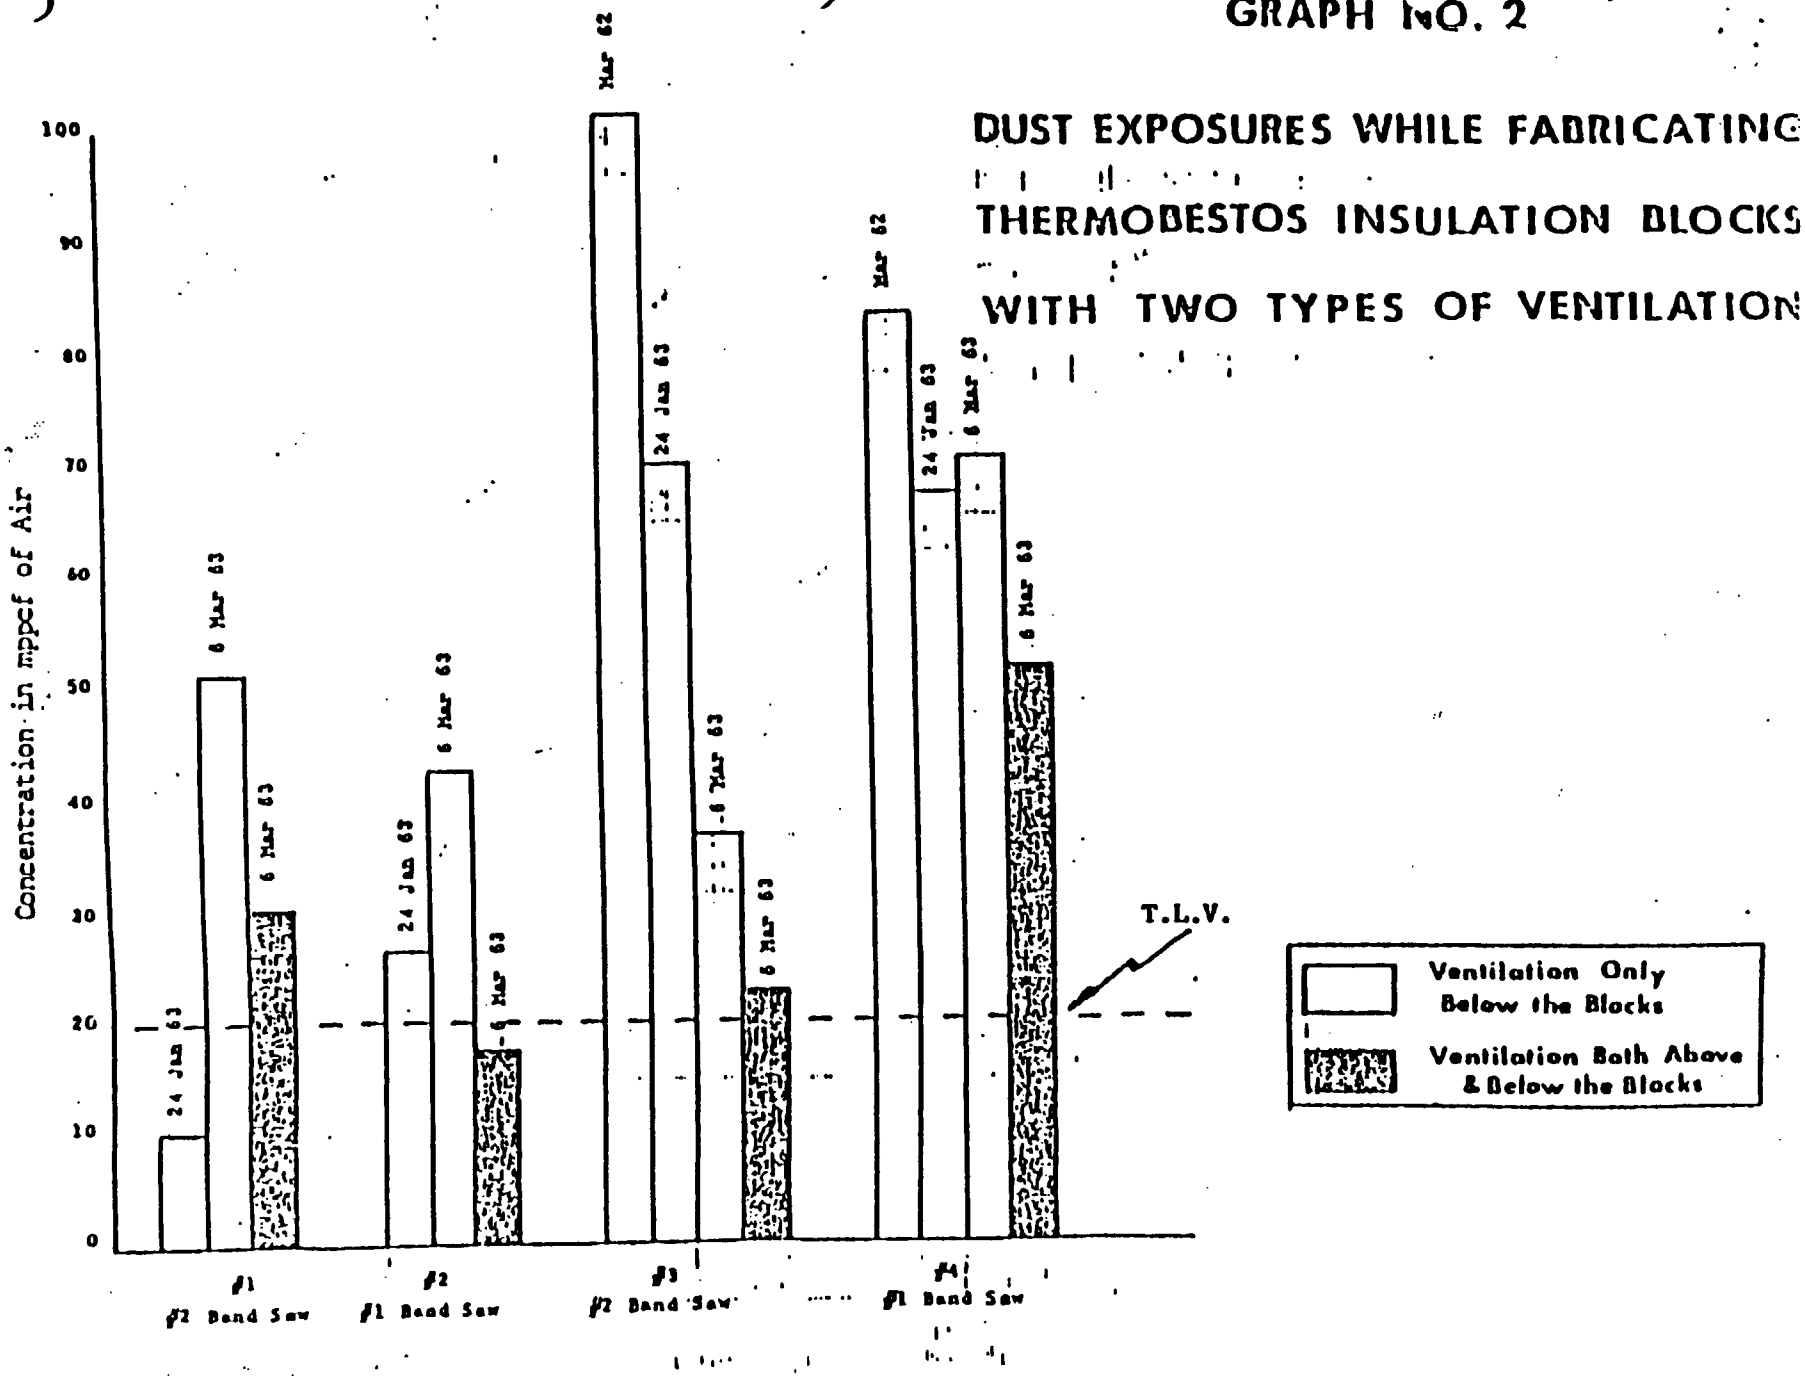
GRAPH NO. 2

1. Methods of handling "Thermobestos" blocks (preparatory to sawing) and scraps (after sawing) contribute greatly to specific individual exposures as demonstrated by the following facts:

a. The fabrication process, which always begins at the #2 band saw with the simple cutting of each 18" x 36" x 4" block into three smaller blocks about 18" x 12" x 4", is normally the least dusty of all the fabrication operations as revealed by the samples taken on 24 Jan 1963.

b. However, on 6 Mar 1963, this operation was revealed as being one of the dustiest, regardless of the ventilation being used.

c. There was only one major variable between the samples taken on the two dates, i.e., the method of handling the blocks preparatory to sawing. Consideration of the procedure used on these dates reveals: (1) that on 24 Jan 1963, the blocks were rolled up to the saw after having been removed from their shipping cartons and stacked on a "dolly" for easy individual removal and (2) on 6 Mar 1963, the blocks were not removed from their shipping cartons until needed by the worker. A large amount of dust is produced when blocks are removed individually from the cartons as a result of the natural abrasion produced when one block is pulled over the surface of the other. Consequently, the dust concentrations on this date at this location were greater than normal.

2. The supplementary overhead ventilation (added since the time of the preceding two reports) does successfully reduce the dust exposures. However, it does not reduce "Thermobestos" dust exposures to within safe acceptable limits when cutting radii.

DUST EXPOSURES WHILE FABRICATING THERMOBESTOS INSULATION BLOCKS WITH TWO TYPES OF VENTILATION

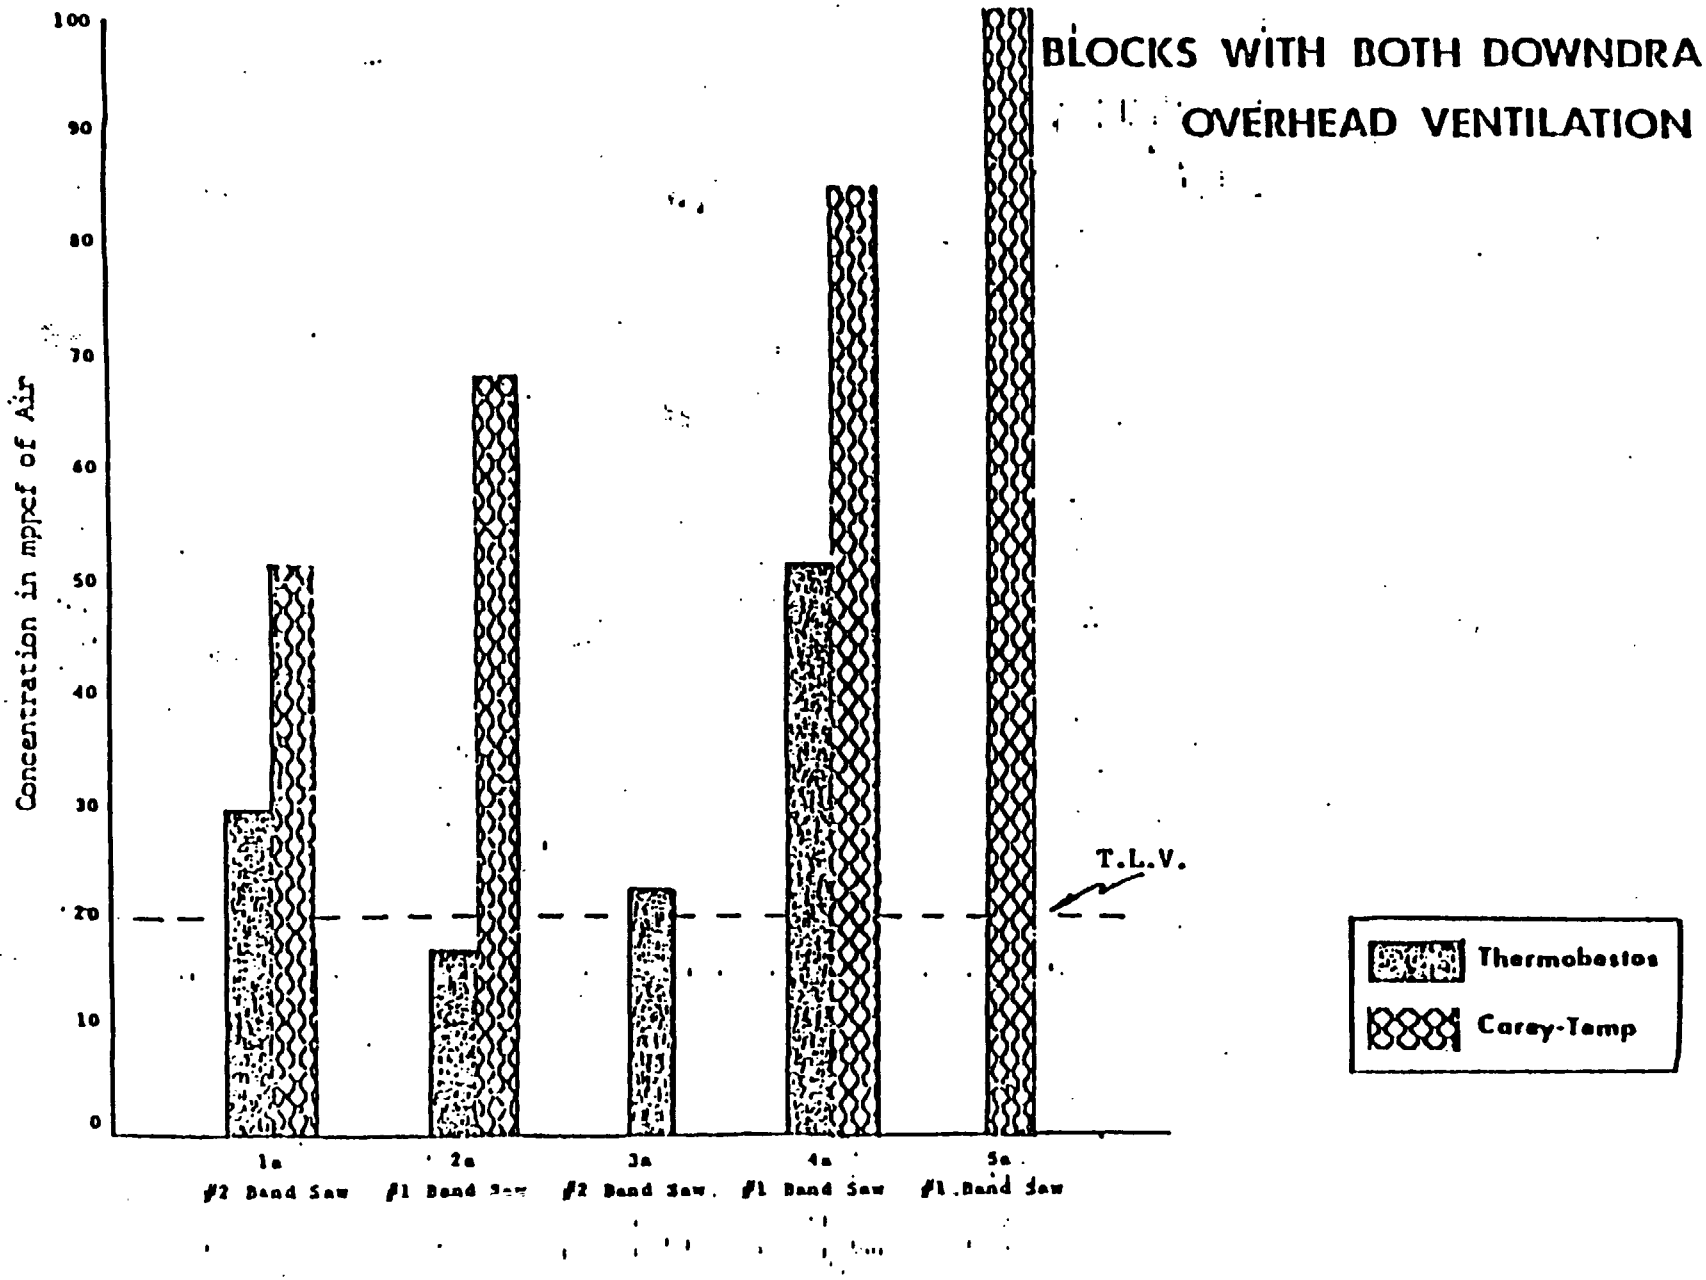
1. "Carey-Temp" dust concentrations for each exposure was substantially greater than the comparable "Thermobestos" dust concentrations and in excess of even the most lenient TLV established for human exposures, i.e., 50 mppcf of air.

2. The existing exhaust ventilation system as installed on both band saws is incapable of reducing the dust hazard, associated with the fabrication of "Carey-Temp", to within safe acceptable limits, i.e., 20 mppcf of air.

DUST EXPOSURES WHILE FABRICATING THERMOBESTOS & CAREY-TEMP INSULATIC BLOCKS WITH BOTH DOWNDRAFT ANE OVERHEAD VENTILATION

1. Do not fabricate 18" x 36" x 4" "Carey-Temp" or "Thermobestos" insulation materials unless:

a. The atmospheric dust problem can be reduced to below 20 mppcf of air through the use of improved ventilation techniques or repairs to the existing system, or

b. The manufacturers of the two makes of insulation materials are able to produce a product which will not release, upon fabrication with a band saw, dust concentrations in excess of 20 mppcf of air.
