Report of Results: MVA0831

Examination of a Grinding Wheel

14 March 1994

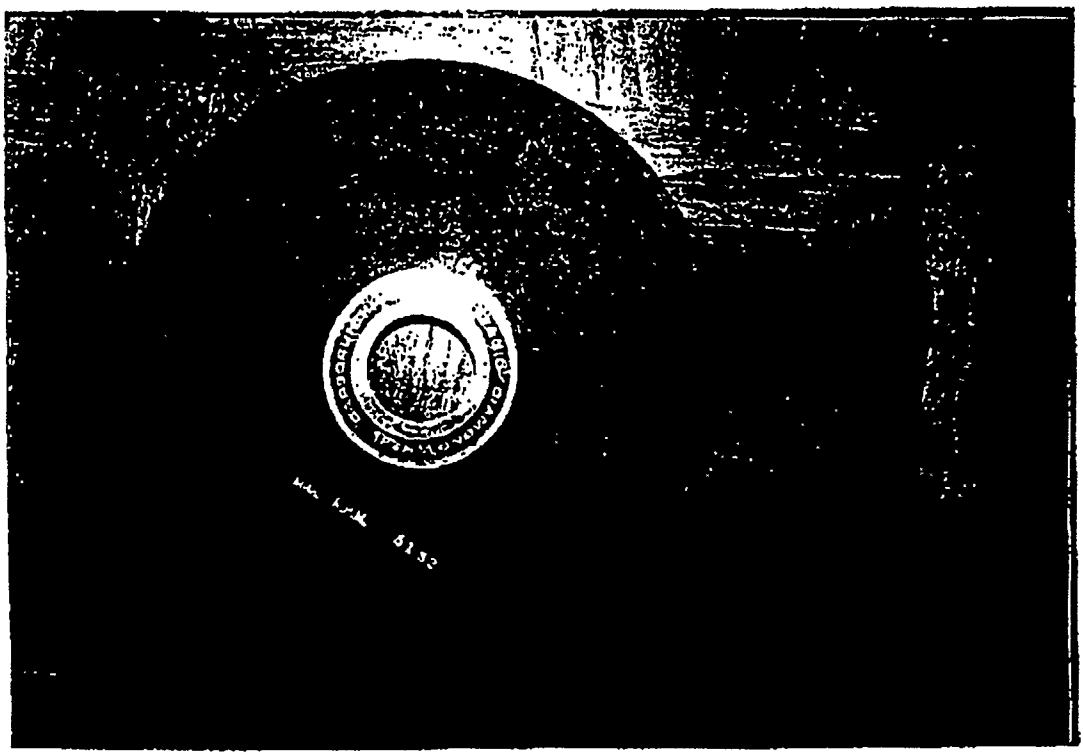
Figure A2. Carborundum Black Magic Diamond Wheel Grinding Wheel with black inner area

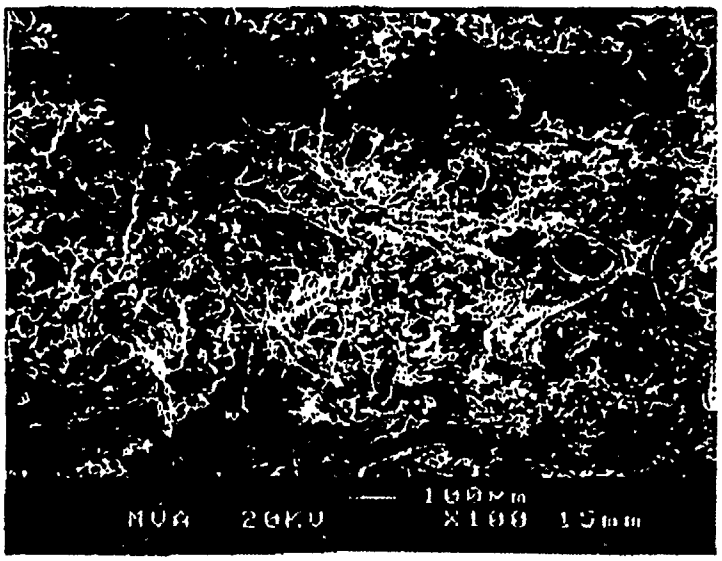
Figure B1. MVA0831-E0424: Secondary electron (SE) image of Post-it note adhesive surface showing chrysotile asbestos fibers. Magnification 100X.

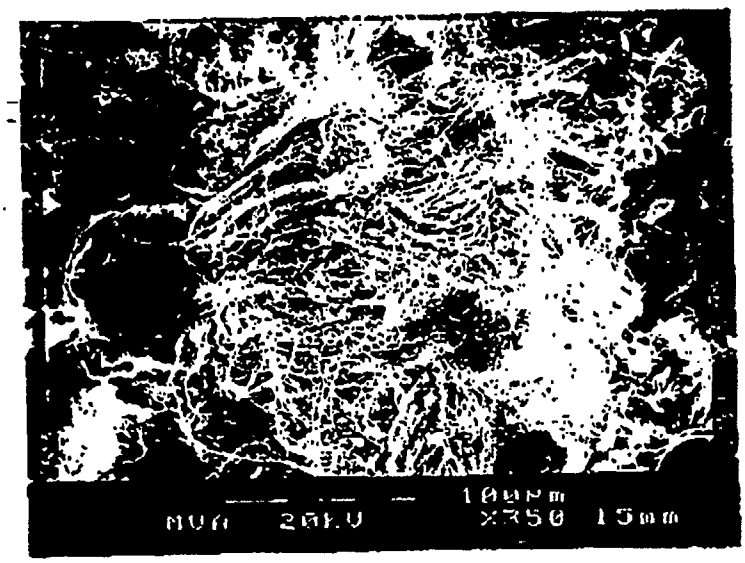
Figure B2. MVA0831-E0424: SE image of Post-it note adhesive surface showing chrysotile asbestos fibers. Magnification 350X.

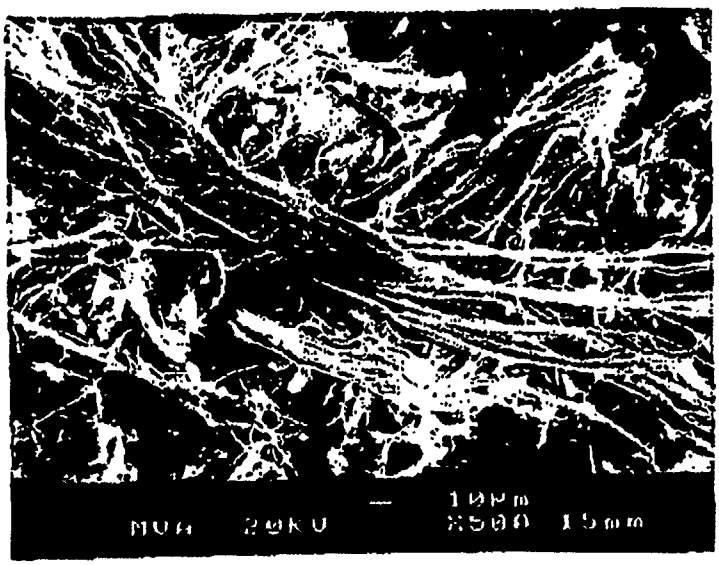
Figure B3. MVA0831-E0424: SE Image of Post-it note adhesive surface showing chrysotile asbestos fibers. Magnification 500X.

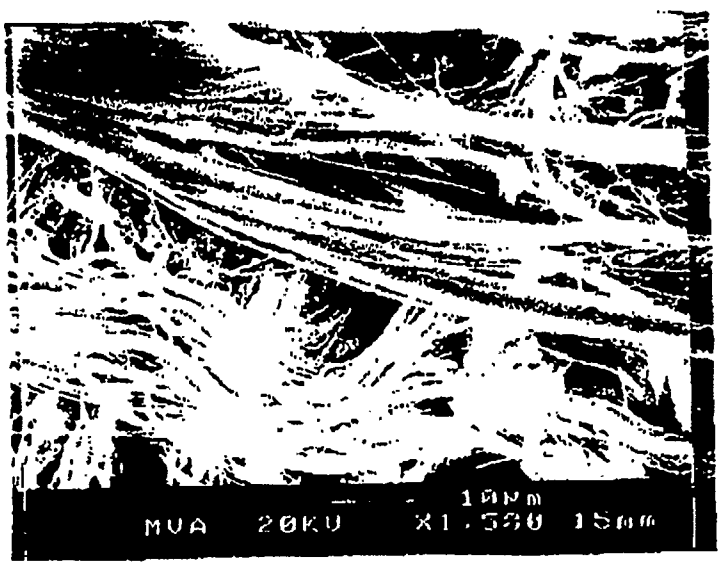
Figure B4. MVA0831-E0424: SE image of Post-it note adhesive surface showing chrysotile asbestos fibers. Magnification 1,500X.

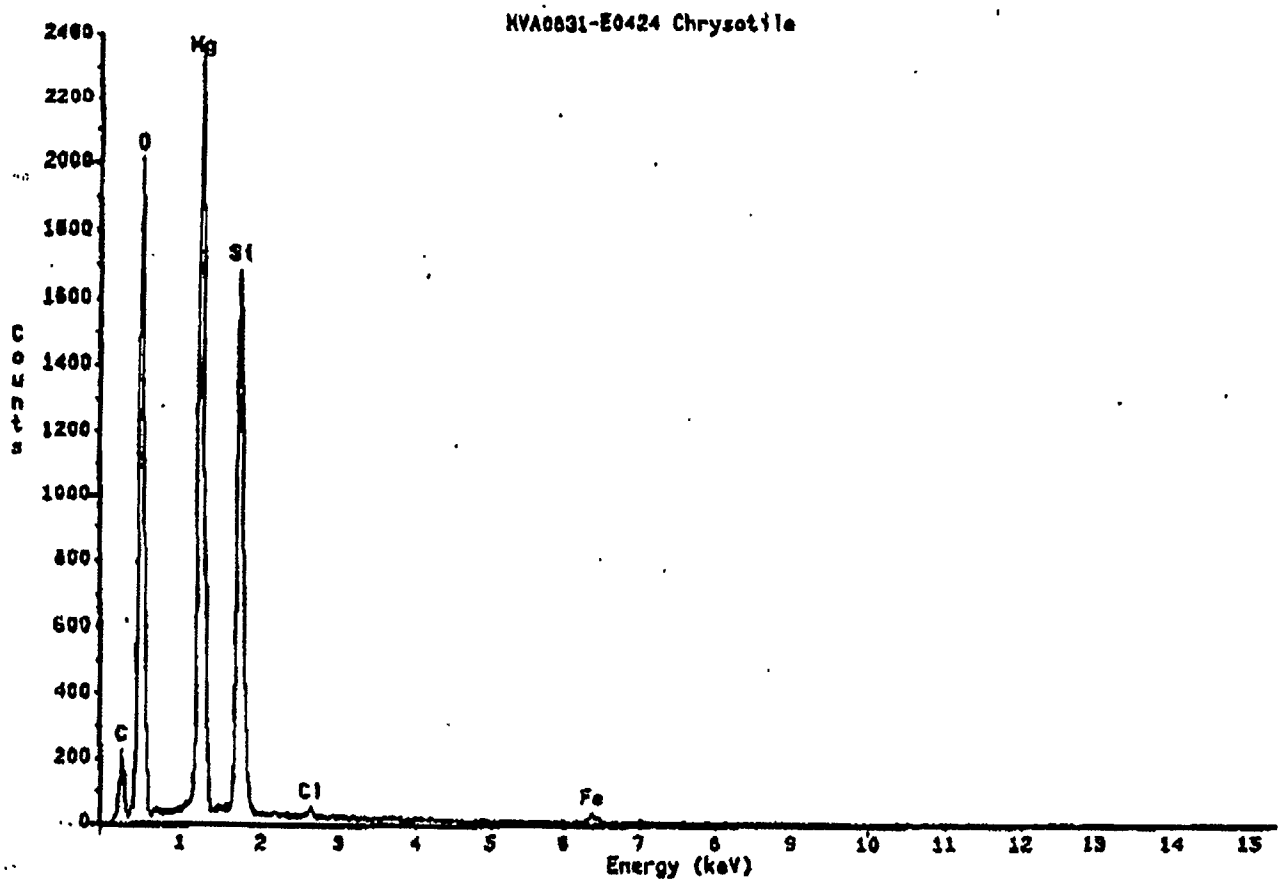
Figure B5. MVA0831-E0424: X-ray spectrum of chrysotile asbestos.

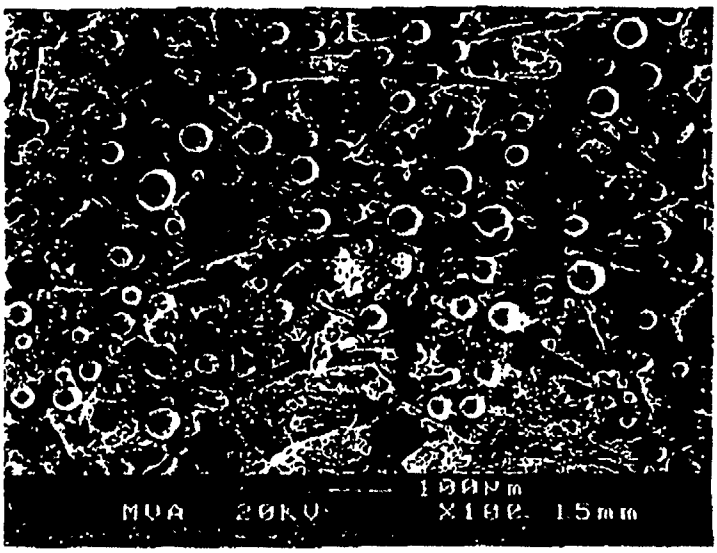
Figure B6. MVA0831-E0427: SE image of Post-it note adhesive surface showing chrysotile asbestos fibers. Magnification 100X.

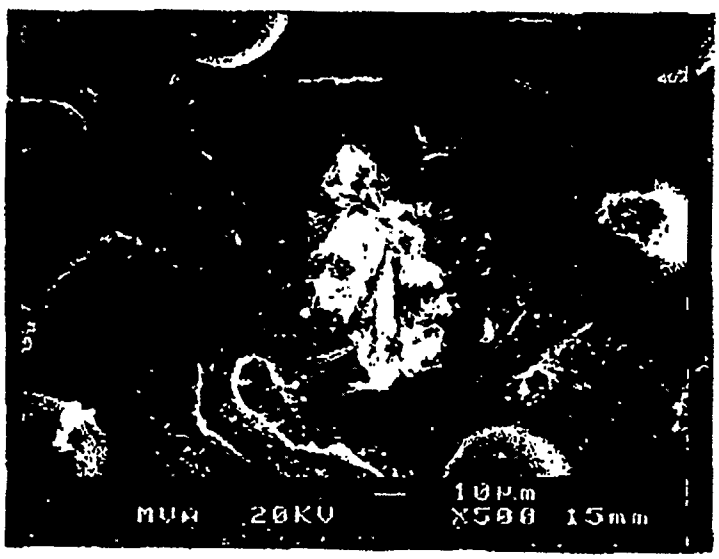
Figure B7. MVA0831-E0427: SE image of Post-it note adhesive surface showing chrysotile asbestos fibers. Magnification 500X.

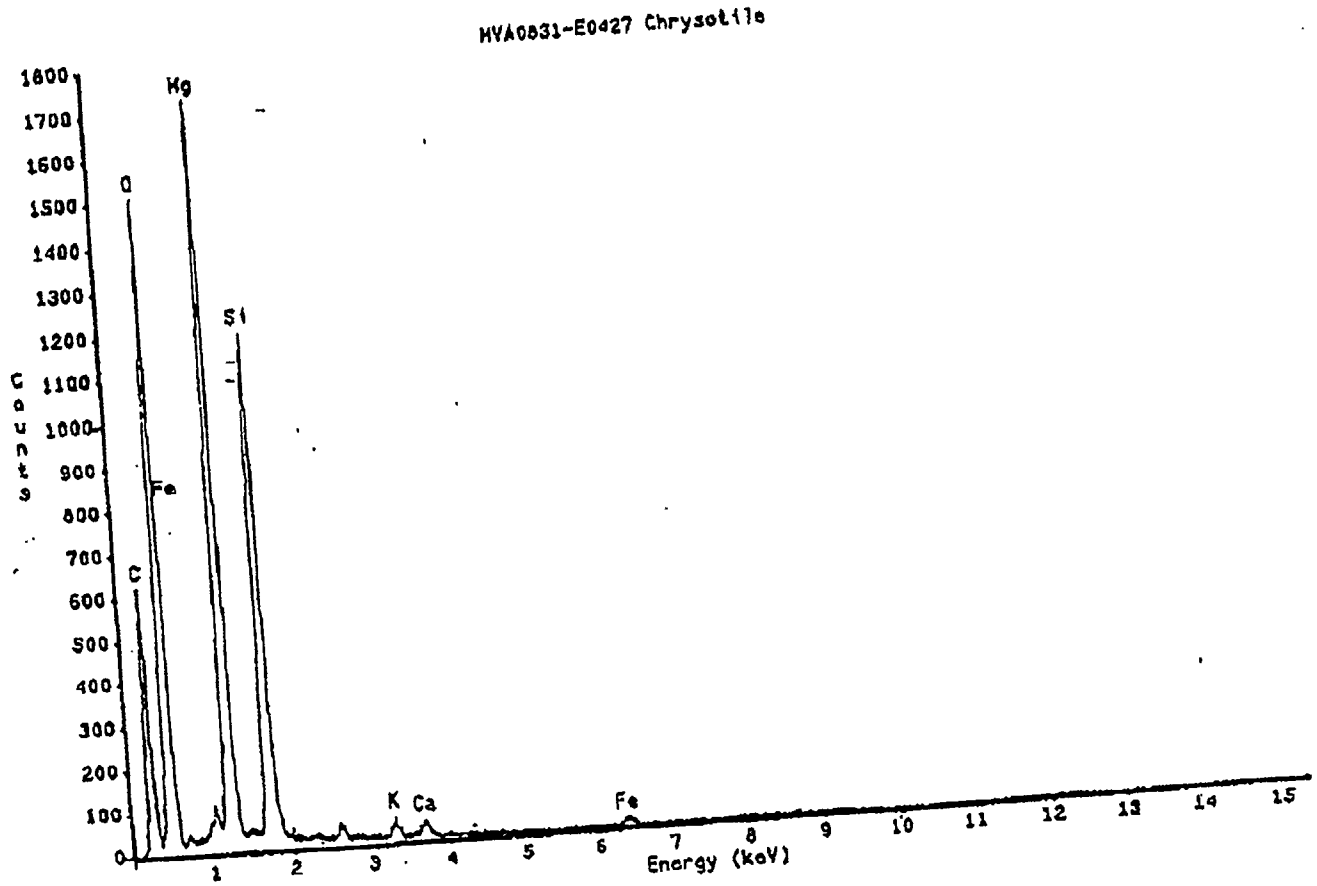
Figure B9. MVA0831-E0427: X-ray spectrum of chrysotile asbestos.
